**D 6.2 Documentation of each study case
CS5 Primary School Hötting, Innsbruck
(Austria)
Delivered at M42**

**[Compatible solutions for improving the energy efficiency
of historic buildings in urban areas]**

Collaborative Project – GRANT AGREEMENT No. 260162

Deliverable D6.2 Documentation of each study case

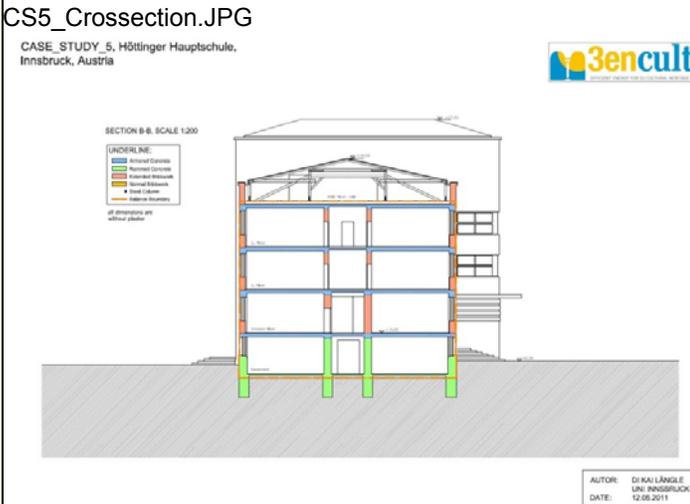
| diagrams/drawings | <p>CS5_Crosssection.JPG</p> <p>CASE_STUDY_5, Höttinger Hauptschule, Innsbruck, Austria</p> |

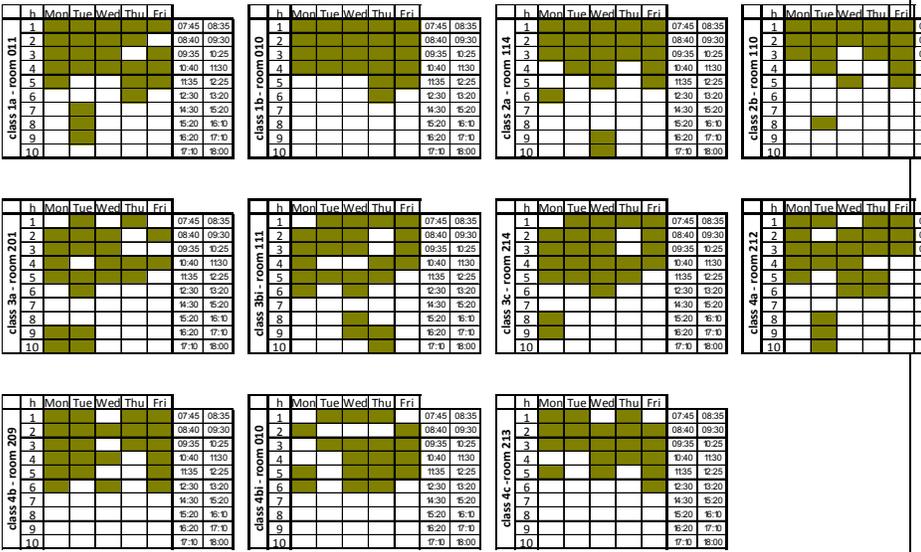
| | <p>Occupation schedule of the class rooms</p> |

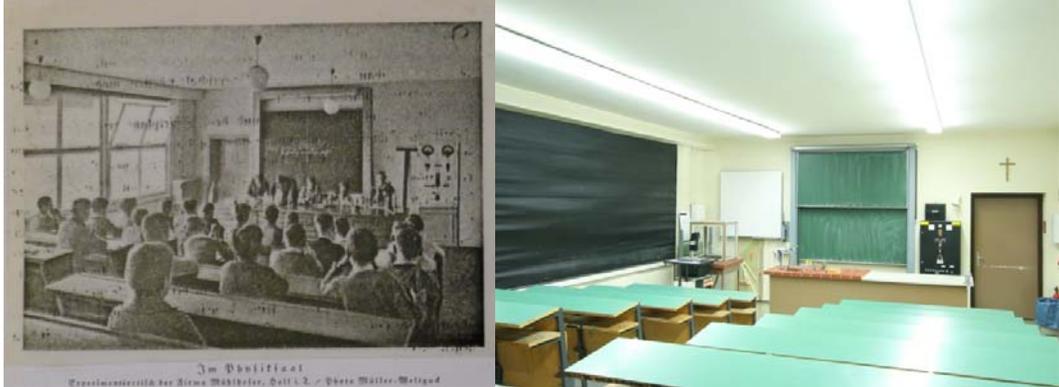
| | <p>Original incandescent light bulb [Festschrift; UIBK, 2012]</p> <p>Besides the advantages of energy efficiency and light quality (color temperature), the LED technology gives new impetus to some further improvements leading to a high quality artificial light in museums and historic buildings for illumination of paintings and artefacts. Solutions able to significantly reduce the electricity consumption due to artificial lighting have been studied, i.e. working with power regulation with respect to the effective visitors present in the room.</p> |

| <p>Artificial Lighting</p> | <p>Energy-saving light sources open a wide range of opportunities besides the saving potentials of electronic ballasts and control. New LED-technology, close to the market breakthrough, gives also the possibility of light temperature control. As a prototype, this technology with daylight adaptive light temperature control was tested in one classroom of CS 5. From cultural heritage authority there was no negative assessment, as the new technology only substitute the fluorescent tube technology, which was not the original type of artificial light either, it was the incandescent light bulb (see Figure: Original incandescent light bulb).</p> |

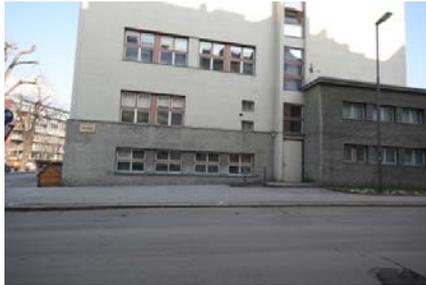
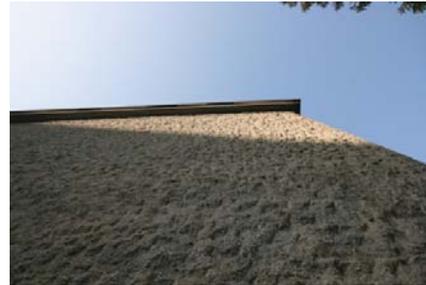
All the external walls of the ground floor and the upper floors are plastered in- and outside with a layer of 2-3 cm of lime-cement-plaster. The external walls of the wing of the gym and most parts of the basement walls are plastered inside with lime-cement-plaster too. At the outside surface of these walls is no additional plaster. The rammed concrete was while drying treated by hand to get a structured surface. This surface is so called “Stucko” (see the Figures below)

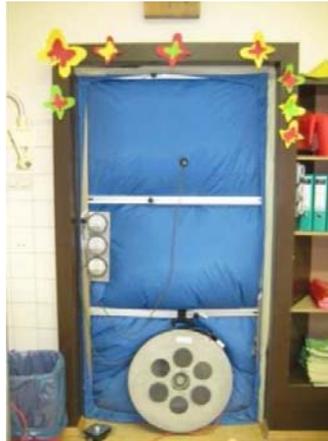
A blower-door test was performed in order to quantify the overall air leakage rate as well as to detect the most important leakages. The result of pressurization test was an n_{50} -value (air change rate at 50 Pa) of 4.8 1/h (+/- 20%) for the school building and 2.8 1/h (+/- 9%) for the gym. In order to see the influence of leakages at the original windows, the blower-door was mounted in a classroom, the result was $n_{50} = 5.8$ 1/h (+/- 6%).

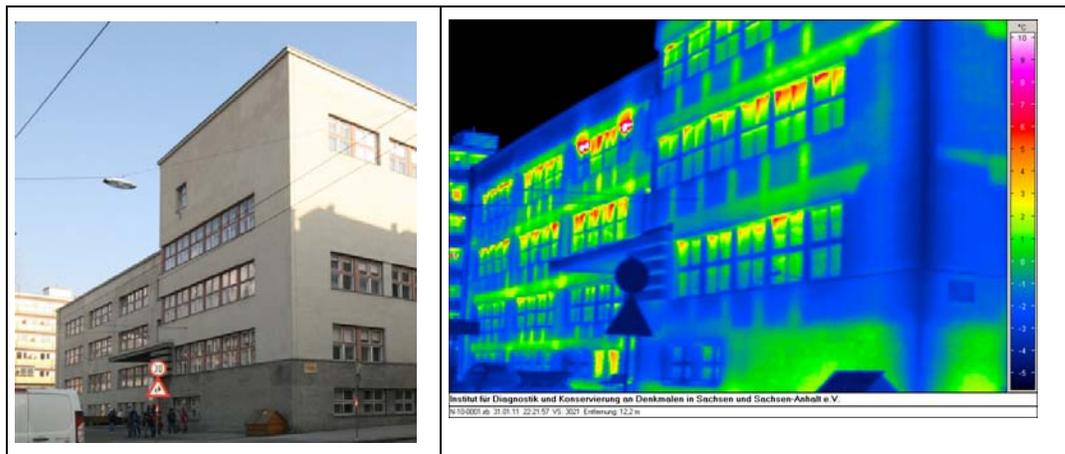
View from West; Source: Christoph Franzen (Institut für Diagnostik und Konservierung an Denkmälern in Sachsen u. Sachsenanhalt), The IR-images were taken during nighttime (31.01.2011) at an ambient temperature of around -5°C . All rooms were heated to an indoor air temperature of around 25°C .

IRT-diagnosis helped to find energy efficient solutions with high priority of conservation-compatibility for all of the interventions (see also [Franzen 2011]).

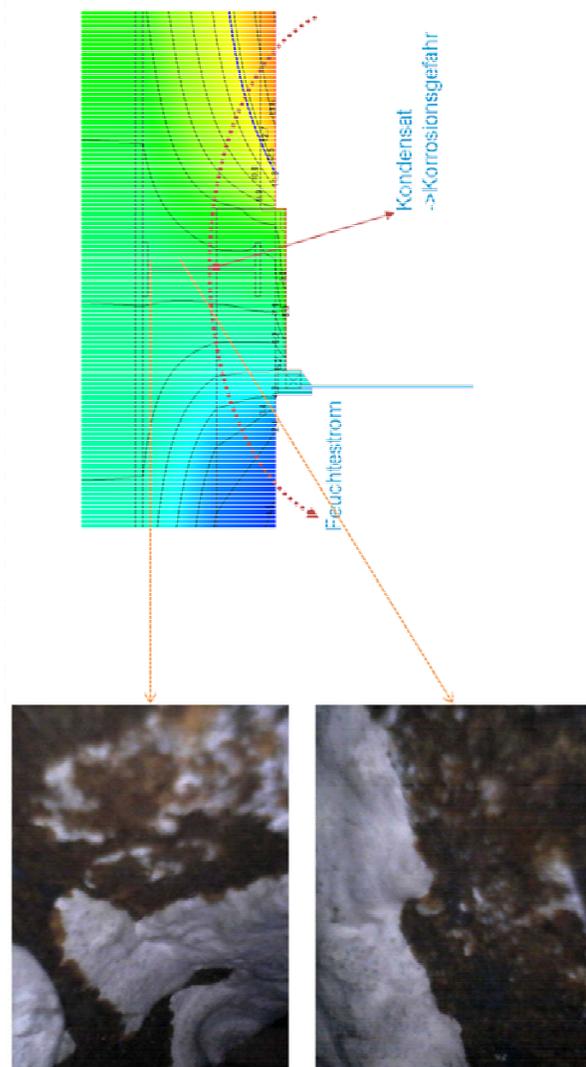
Detail of Roof: steel-stone ceiling with concrete topping,
 Screed / Flooring: stone wood flooring with covered training (Magnesite coating)
 Floor surfac in class rooms: corklinoleum.

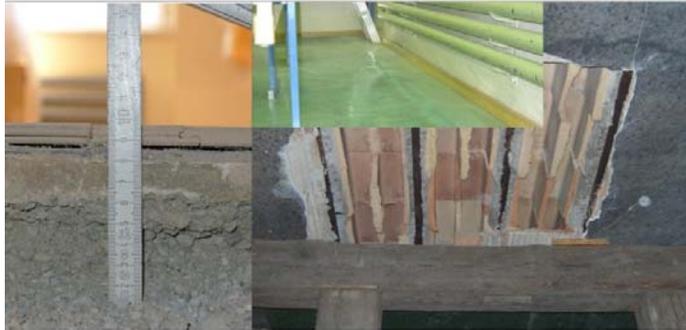
Steinholzböden: Problematik „Magnesiumoxychlorid“

- Report written by Assistant Professor Gerd Fritsche
- Ceiling structure at the end of the service life
 - Immediate action required
 - Carbonation progressed, no corrosion protection!
 - Check-ups every 10 years necessary
 - Renovation in the former coal cellar urgently required

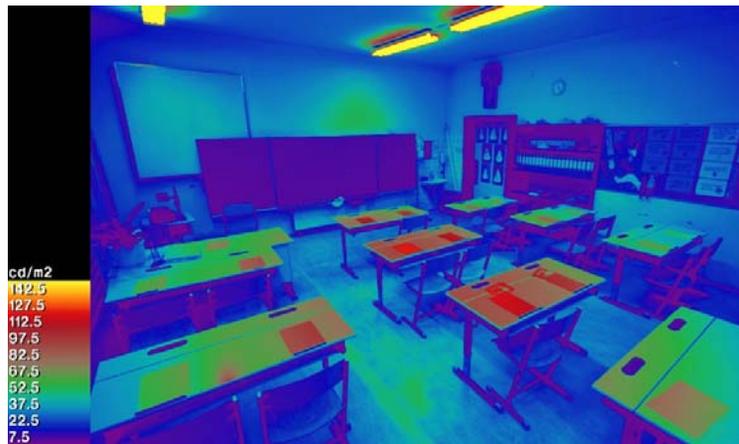
Luminance measurement in the classroom with artificial light

The acoustic (reverberation time) and visual comfort (daylight coefficient and artificial light distribution) was measured as well. Figure below shows a luminance measurement of the class room before intervention with poor artificial lighting (on two-third of the tables only 150 lux were measured, see also [Pfluger 2011]).

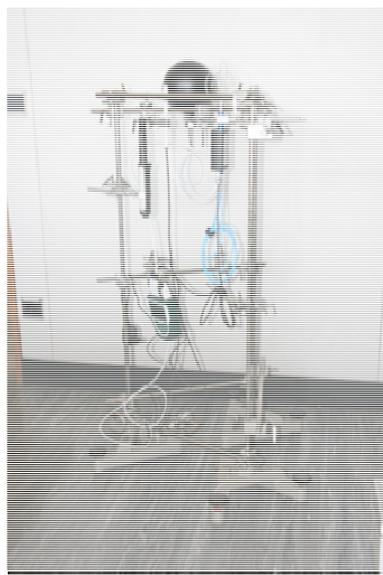
Sensors for assessment of thermal comfort and for CO₂ measurement (assessment of air quality).

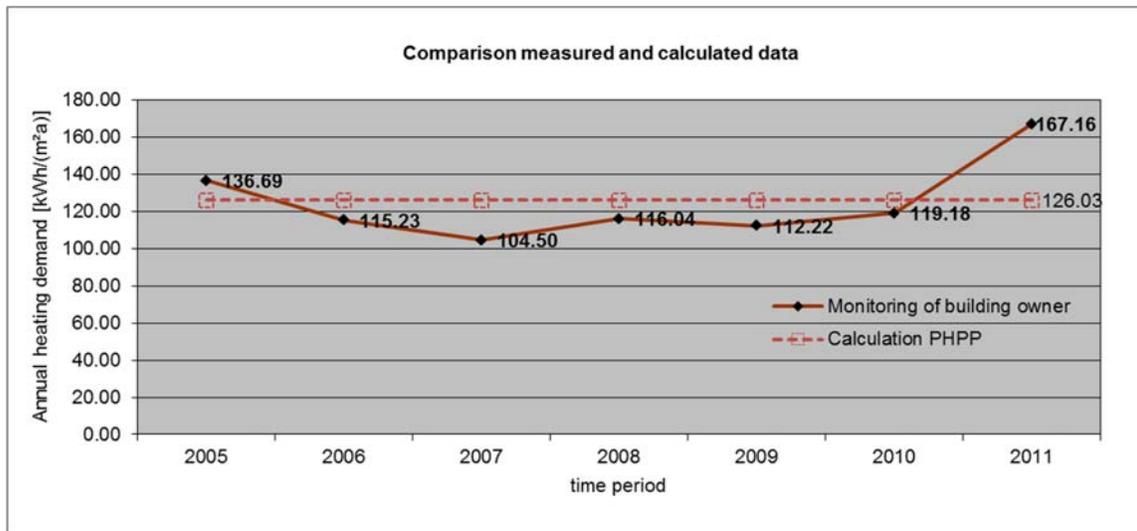
Diagram with the measured and calculated energy balances in the period from 2005 to 2011

In the diagram is clearly visible, that the values of the measured energy balance of the last seven years commute around the annual heating demand, which was calculated with the PHPP. Depending on the climatic conditions of the different years the values of the energy balance is only in average 10% below or above the calculated annual heating demand. Only the measured value of year 2011 is 32% above the calculated level. This higher consumption may result from the extreme cold winter in 2011. But the difference between the mean value of all the monitoring data between 2005 and 2011 and the calculated data resulted with less than 2 kWh/ (m²a) difference, what can be considered as very precise. Hence the PHPP model was considered as a verified for further research of refurbishment variations and the PHPP tool itself has proved its applicability also to historic buildings.

In the diagram below the measured annual heating consumption and the comparable values calculated in PHPP are presented.

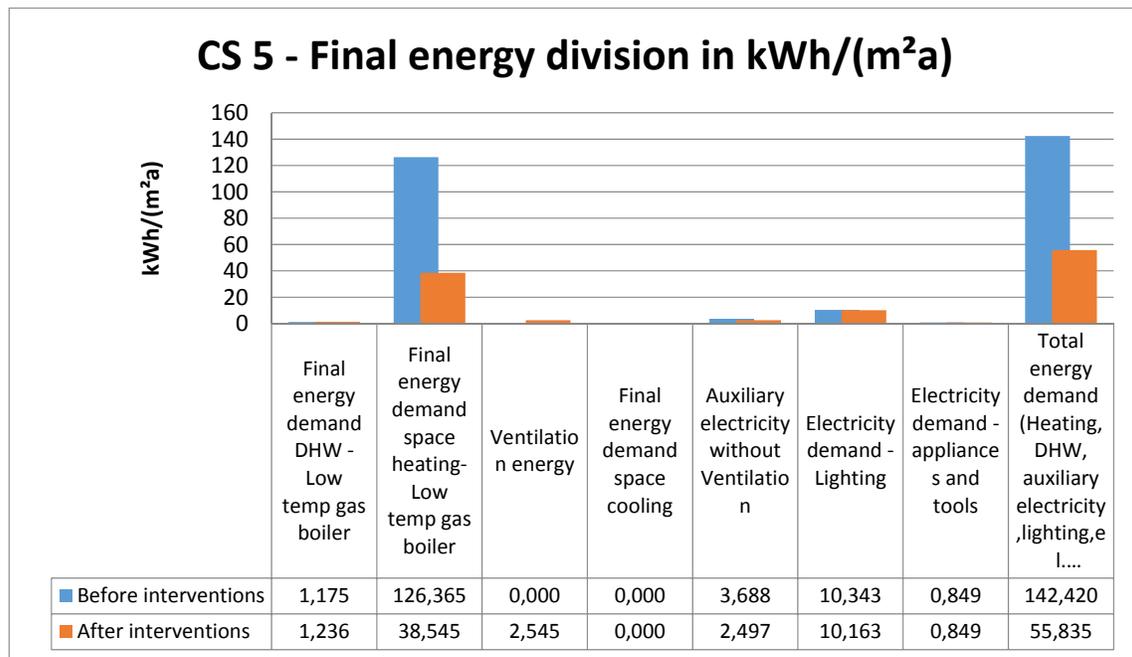
CS 5 - Final energy division

On the **Fehler! Verweisquelle konnte nicht gefunden werden**.above and below can be seen closed division of energy consumptions outlined by PHPP simulation tool. The variation after intervention contains all proposed energy efficient solutions.

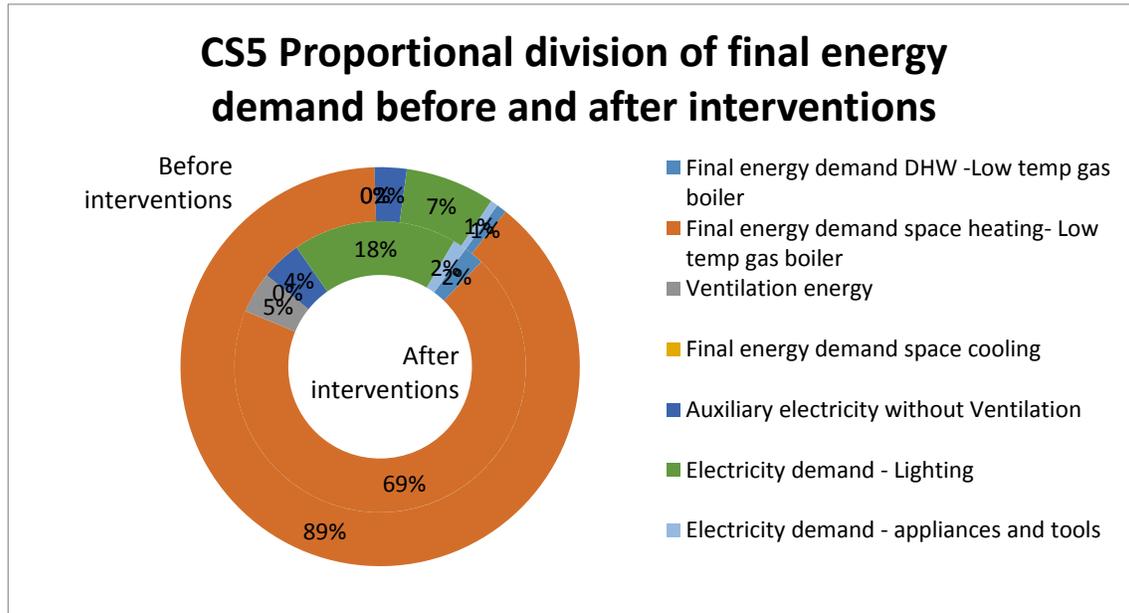
CS5 Proportional division of final energy demand before and after interventions

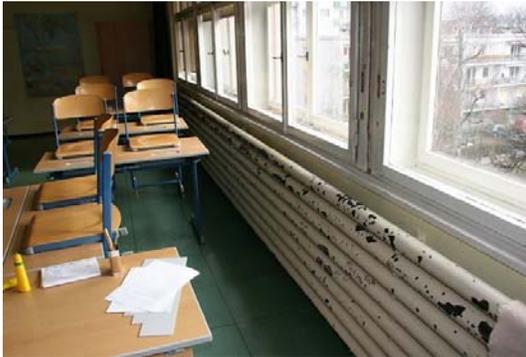
Manifold radiators in classrooms

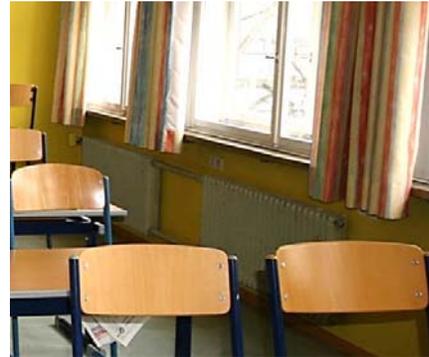
Lamellas radiators in classrooms

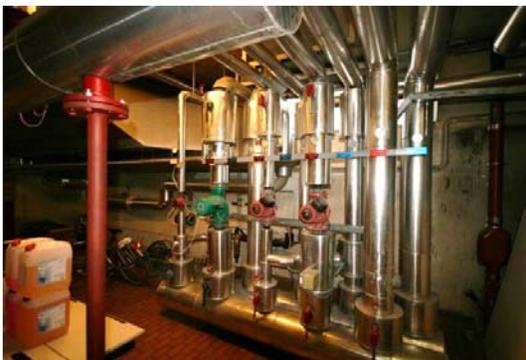
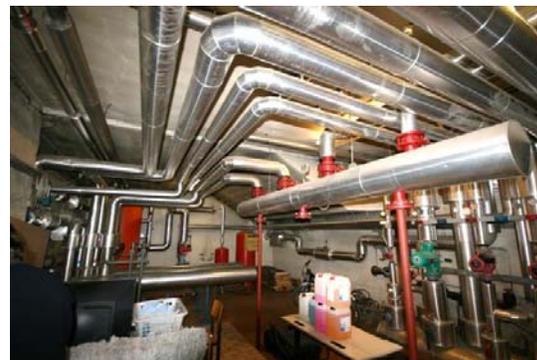
Distribution system located in the basement

The boiler is situated in the cold attic in the third floor and the distribution for the heating system including all components such as pressure compensation container is located in the basement (see Figures below). Furthermore the installations to produce, store and distribute the drinking hot water are installed in this room.

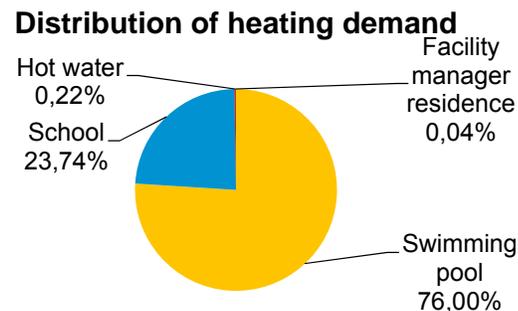
Diagram of the heating demand distribution

The heating supply of the school was changed a few years ago. The new gas boiler to provide the heating demand is situated at the third floor in the cold attic. It is installed there because of safety reasons and due the fact that the building was not considered at the first erection for installation of such a huge boiler. The new gas boiler supplies the energy demand of the school and of the public swimming pool, located nearby opposite of the street in west direction. From the boiler the warm water is led over a riser duct to the distribution system in the plant room in the basement. After the distribution dominant amount of the warm water is led along the inner side of the external wall to the northwest corner of the building and then below the street to the swimming pool. About 76% of the in the school produced energy is provided to the swimming pool (see **Fehler! Verweisquelle konnte nicht gefunden werden.**). All the ducts are well insulated but although a lot of energy gets lost. Especially the losses of the riser ducts between the boiler located in cold attic and the distribution system in the basement are not taken into account in the measured energy balance, because the heat meters are mounted at the distribution system downstairs. This fact is important for the comparison of the measured and calculated energy consumption values (see below).

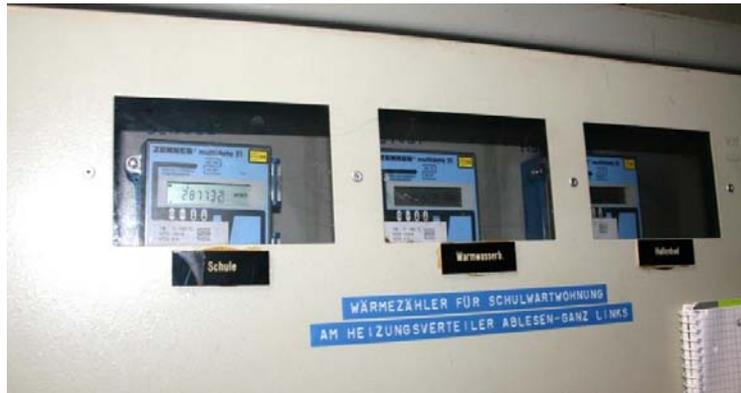
Installed heat meters located in the plant room

To distinguish between heating costs of the school and of the swimming pool the building owner installed heat meters at the distribution system located in the basement (see figure below). The first heat meter is counting the heat consumption for the heating system of the school building. The second one is measuring the consumption for the supply of the drinking hot water and the third one is counting the energy supplied to the swimming pool. Hence, the consumptions of the various systems are clearly recognizable.

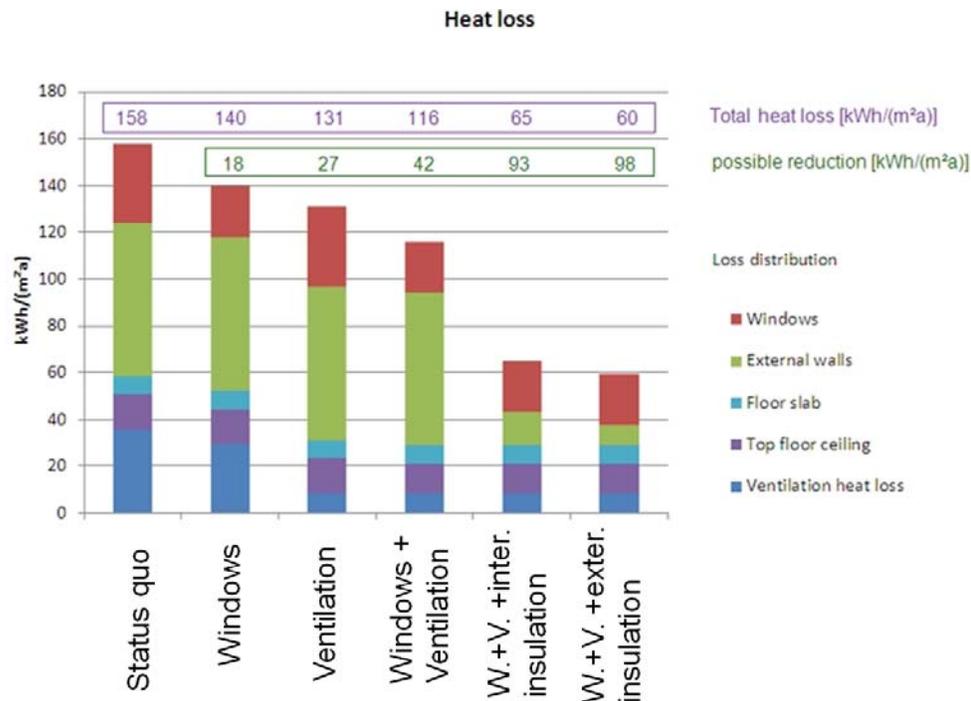
Diagram to compare the heat losses of different refurbishment solutions

For example the difference between the calculation of variant 1 “before intervention” and variant 2 “Windows” is only the input of the g- und the Ug-value of the glazing of the box-type window in the sheet “WinType”. The changes were carried out in the new sheet “parameter”. This function was developed by Passive House Institute for purposes of the 3ENCULT project.

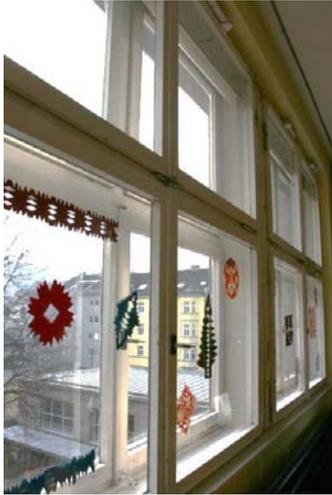
Original box-type windows in the classrooms

The biggest share of airtightness heat losses are caused by old **windows**, thus its replacement by more airtight once with a better U_g -value would result in reduction of annual heat losses by 18 kWh/ (m²a).

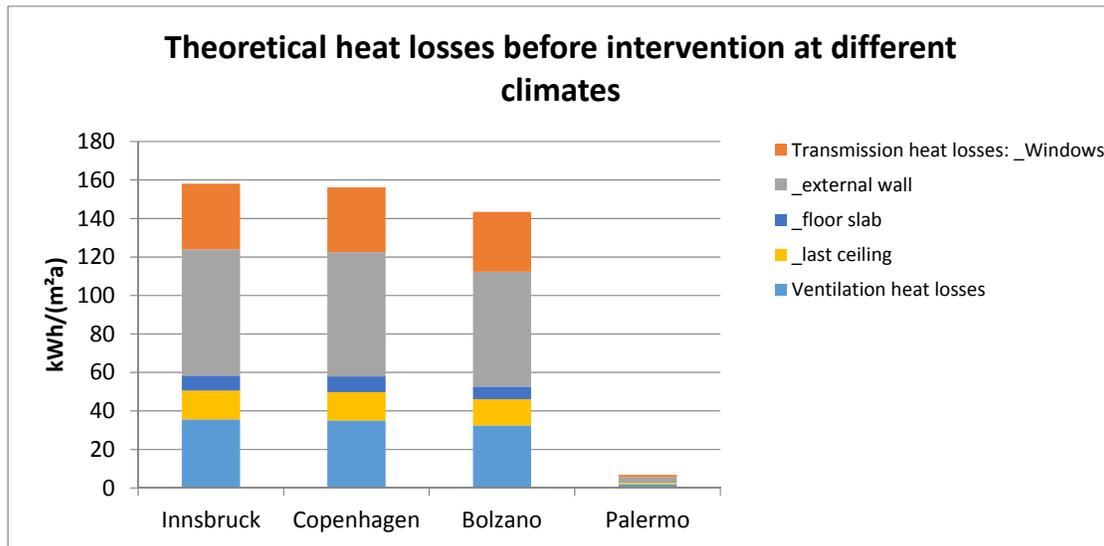
Theoretical heat losses before intervention in Innsbruck, Copenhagen, Bolzano and Palermo

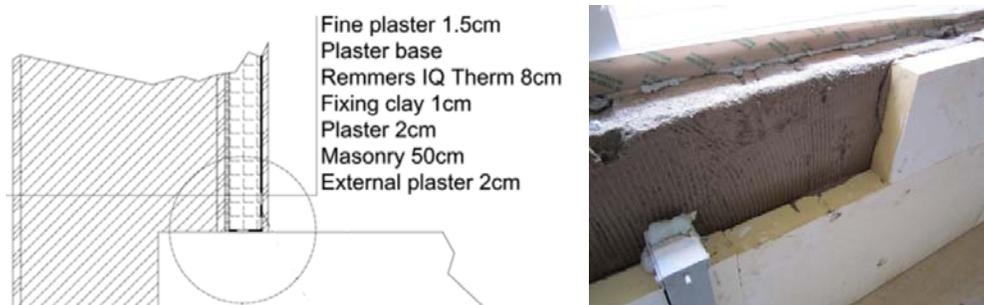
PU-foam insulation in combination with capillary active clay

Thermal conductivity of the capillary active insulation is 0,033 W/mK.

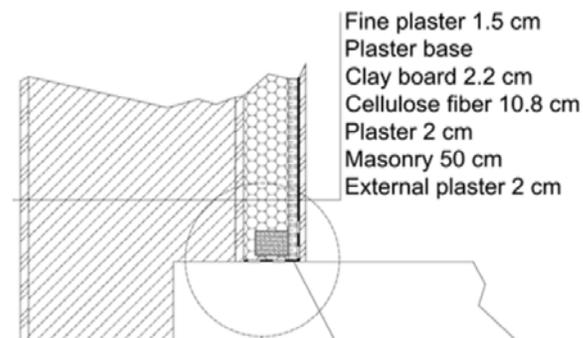
Cellulose fibre and clay boards

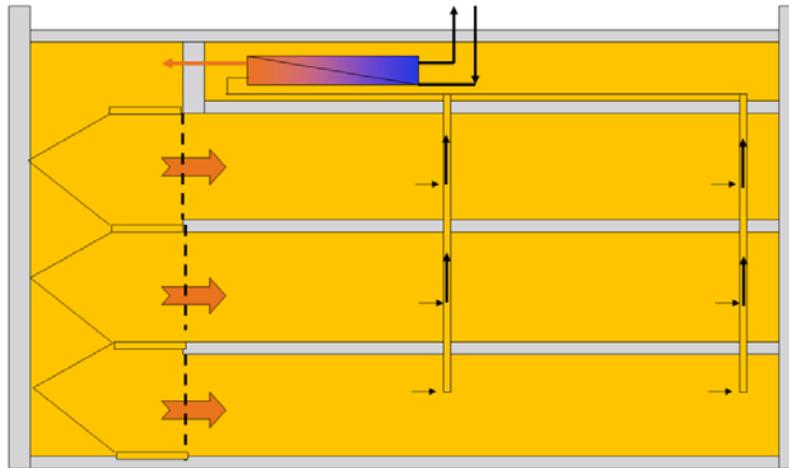
Cross section of the central overflow mechanical ventilation system concept

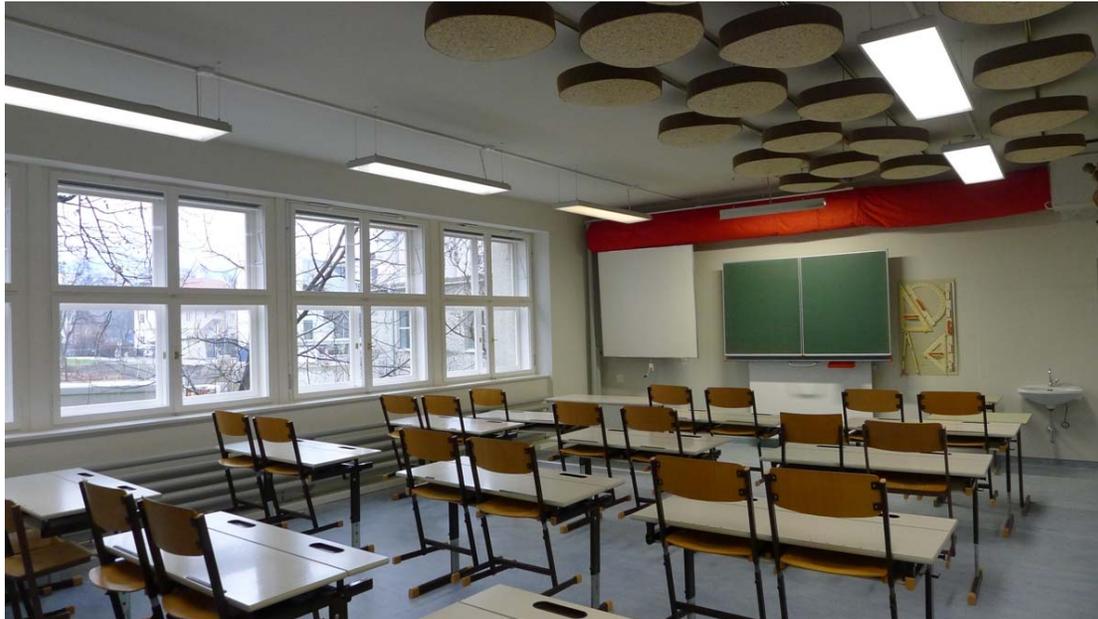
Prototype class room 1

- Wall insulation: Capillary active internal insulation (Remmers IQ-Therm)
- Original windows enhanced with heat protection glass and sealing lips
- Shading and daylight redirection lamellae integrated in box-type window
- Artificial light by LED-technology with adaptable colour temperature and automatic dimming
- Sound absorber made from organic fibre
- Ventilation air distribution via laser perforated textile diffuser

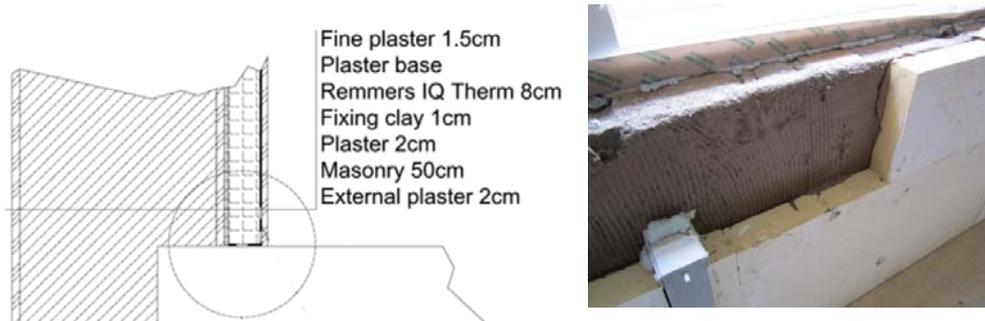
PU-foam insulation (thermal conductivity 0.033 W/mK) with integrated silicate wicks and vapour open plaster glued to the wall with capillary active clay (reversibility)

Room 1: a PUR foam board glued with loam to the wall, with integrated silicate wicks and vapour open plaster, bringing humidity from within the wall to the interior warm side.

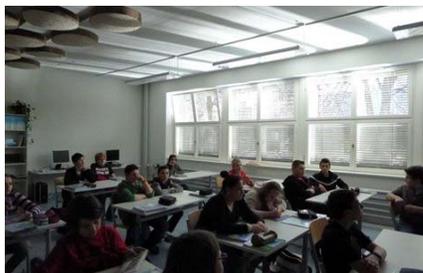
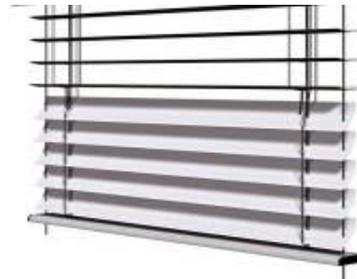
Daylight redirection to the ceiling by the upper part of the lamellas and sun-blocking at the lower part helps to enhance daylight autonomy without glare problems

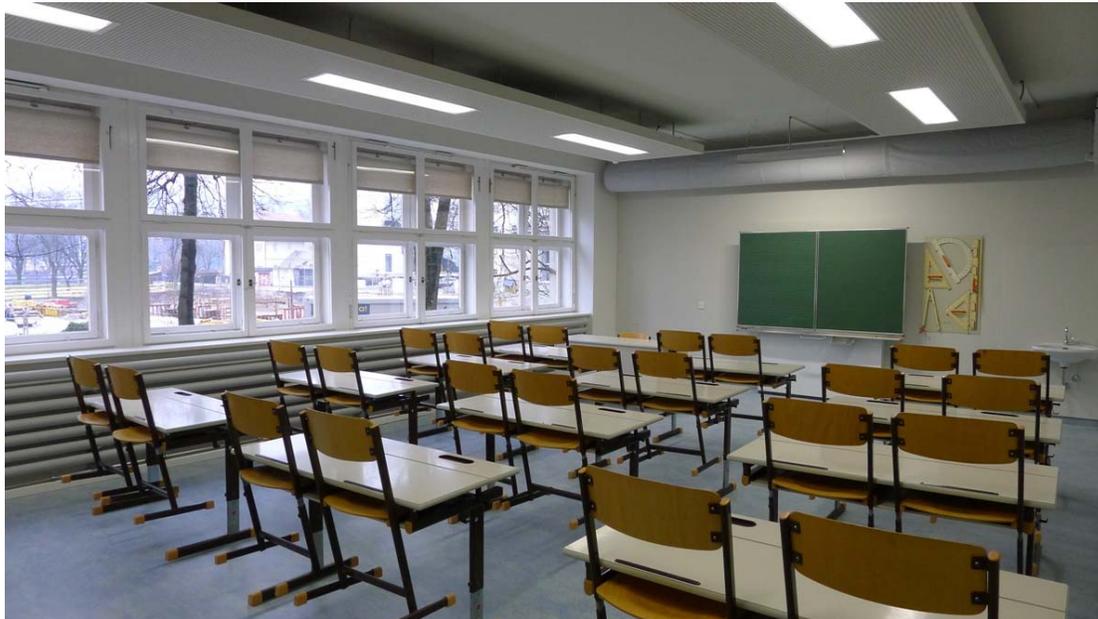
Prototype class room 2.

- Wall insulation: Internal insulation by cellulose fibre
- Original windows restored and painted
- Shading by textile screen integrated in box-type window
- Artificial light by high efficient fluorescent lamp and glare suppression
- Sound absorber with integrated artificial light
- Ventilation air distribution homogeneous perforated textile diffuser

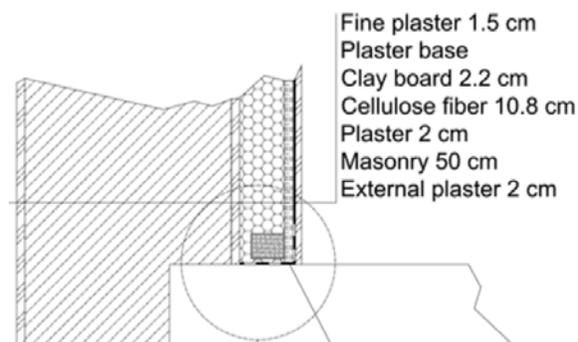
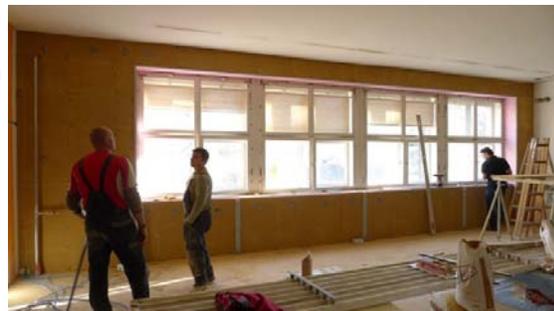
Interior insulation with cellulose fibre (thermal conductivity 0.04 W/mK) and clay boards with clay fine plaster

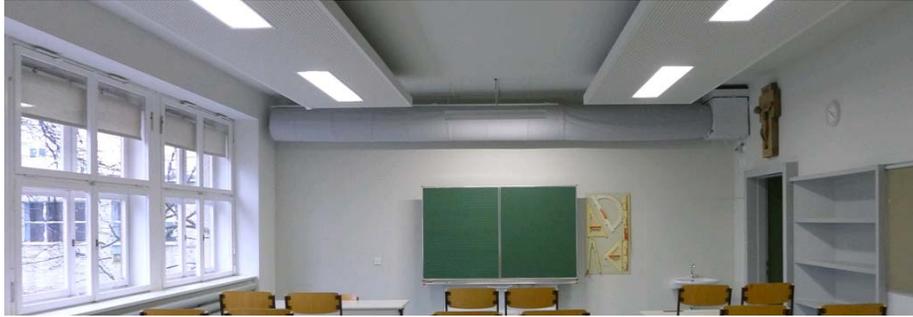
Silencer and fan-box prototype manufactured by ATREA

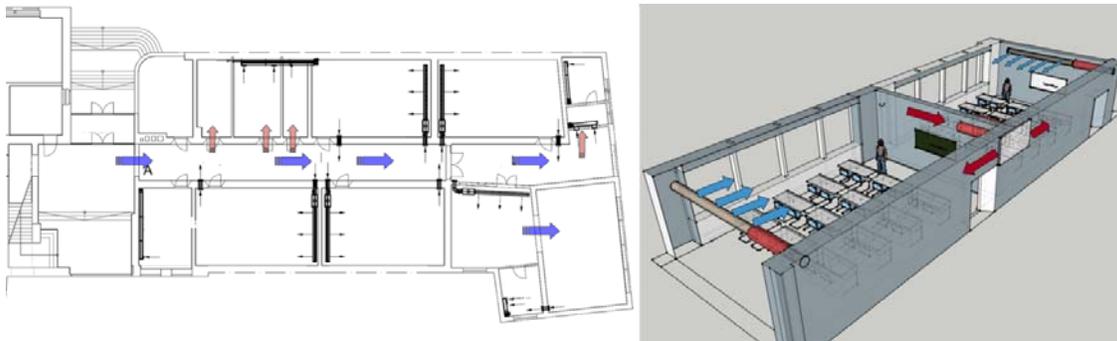
Active overflow principle (supply air from corridor distributed in the class room, extract air is vented back to the corridor via silencers)

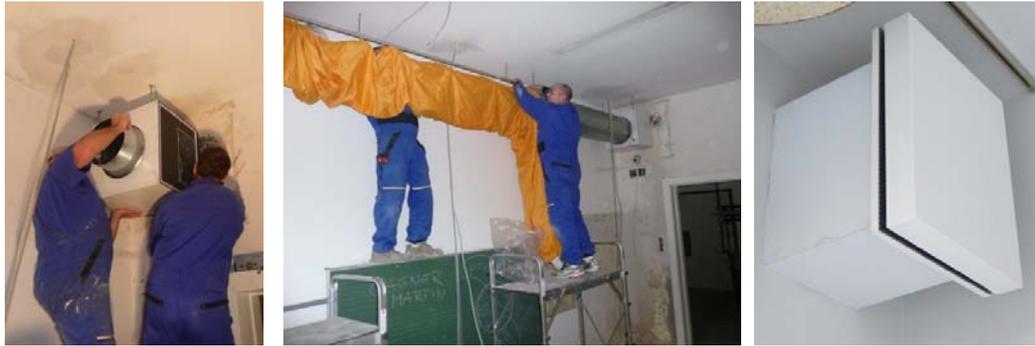
Supply air distribution and overflow (upper left), mounting of the fan box (lower right) and overflow silencer (lower right)

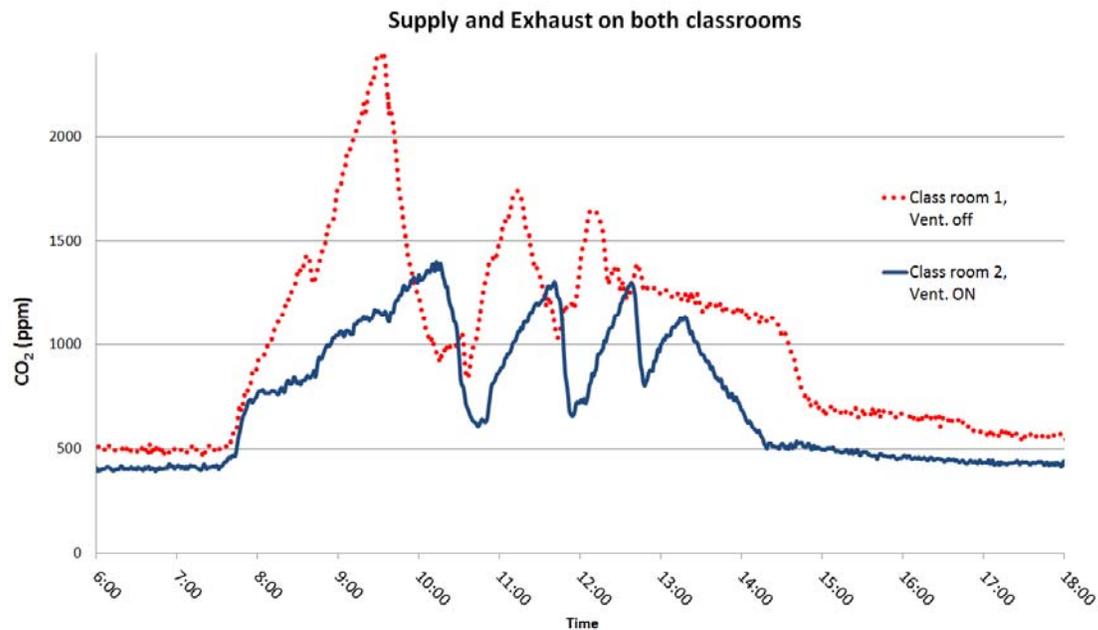
On the Figure above is showed a side-by-side result of CO₂ measurement of two identical classrooms where the ventilation was running in Class room 2 and Class room 1 was not actively ventilated.

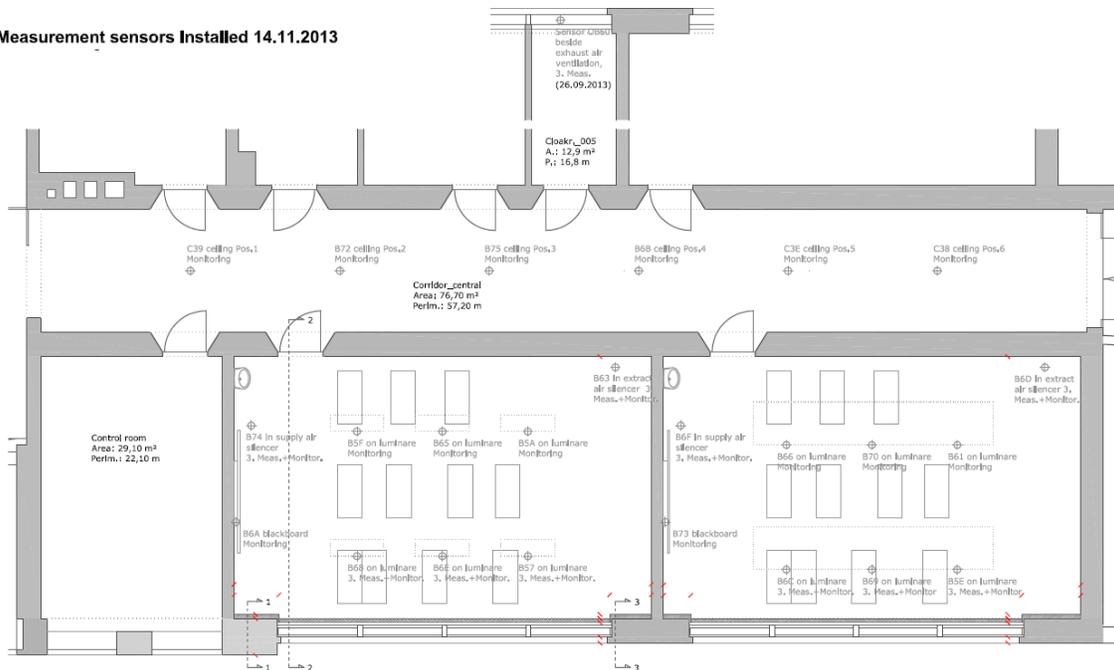
On the Figure above is illustrated the placement of CO₂ monitoring sensors in both Class room and in the corridor.

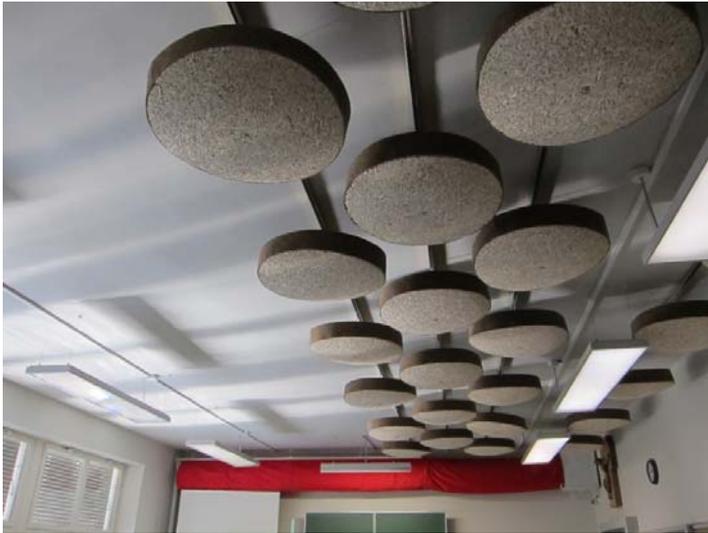
Acoustic elements (made by ORGANOID) in combination with daylight redirection)

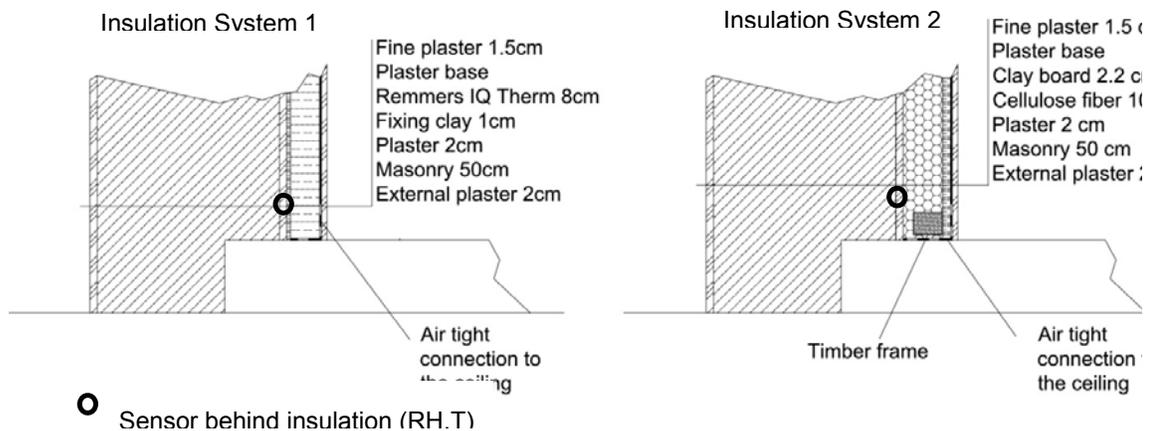
Vertical sections of the wall-ceiling junction. Insulation system 1: PU-foam insulation in combination with capillary active clay (left). Insulation system 2: Cellulose fibre and clay boards (right)

In November 2012 two classrooms have been provided with different internal insulation systems for testing. The employed insulation materials are PU-foam in combination with capillary active channels and clay glue for the first system (IQ-Therm system, figure below, left) and blow-in cellulose for the second one (, right). Capacitive sensors have been installed for monitoring of temperature and relative humidity at different positions (between insulation and masonry, at the internal and external surfaces and in the surrounding ambient). The analysis of the measured data aims to select the most appropriate solution to be employed for the retrofitting of the whole building, with respect to the moisture damage risk.

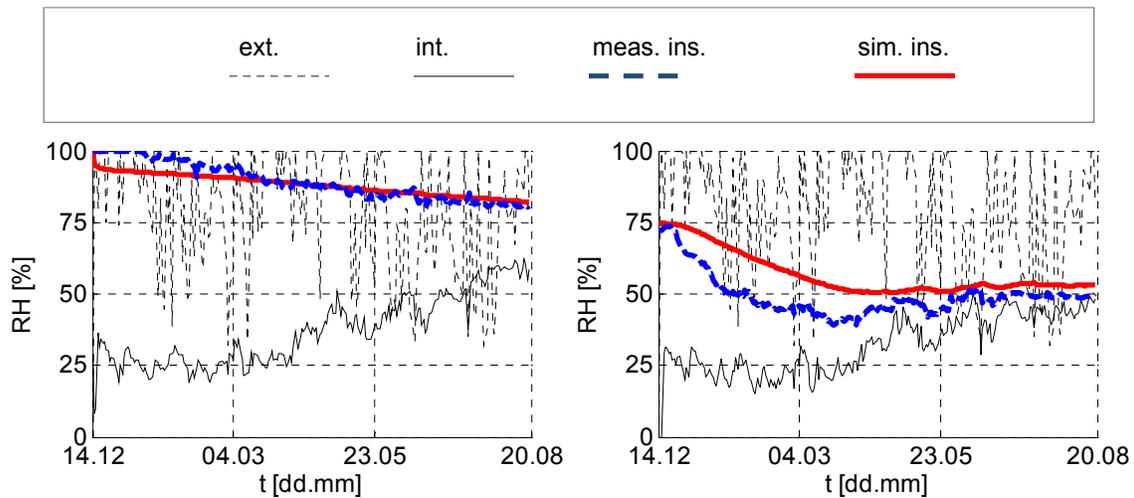
Evolution of the relative humidity (left: system 1, right: system 2) over the monitored time period (Dec.2012-Aug.2013). External (ext.) and internal (int.) values as well as measured (meas.) and simulated (sim.) values behind insulation (ins.).

In figure below the temporal evolutions of measured relative humidity behind insulation for both the test-rooms are reported and compared with simulation results. The simulations have been performed with a finite-volumes based program ["Delphin Software," 2011], employing 2D models. Figure below reports also the internal and external relative humidity values. The numerical results show satisfactory agreement with the measured values, demonstrating that the assumptions on the material data and boundary conditions used for the simulation are adequate. From the temporal evolution of relative humidity, it can be observed that both constructions are drying. However the first test-room (figure below, left) presents values of relative humidity under the insulation starting from 100%. This can be explained, considering that the fixing-clay used for the insulation boards has to be applied wet. The very slow drying process of the construction can represent a drawback of this system, since the favourable conditions for germination of mould are present behind the insulation over a long period of time (relative humidity over 75% all over the monitored period). Hence, air voids behind insulation, inside which germination could start, have to be carefully avoided.

The cellulose-based system (figure above, right) presents non-critical values of relative humidity, therefore it can be considered appropriate for this application. However, it has to be noticed that the internal relative humidity remains very low during the whole winter period (around 25%) due to the moderate humidity sources and active ventilation in the classrooms. Numerical simulation has shown that higher internal moisture sources or limited air exchange rate can lead to modified conditions under the insulation [Janetti et al., 2013], hence mechanical ventilation is recommended.

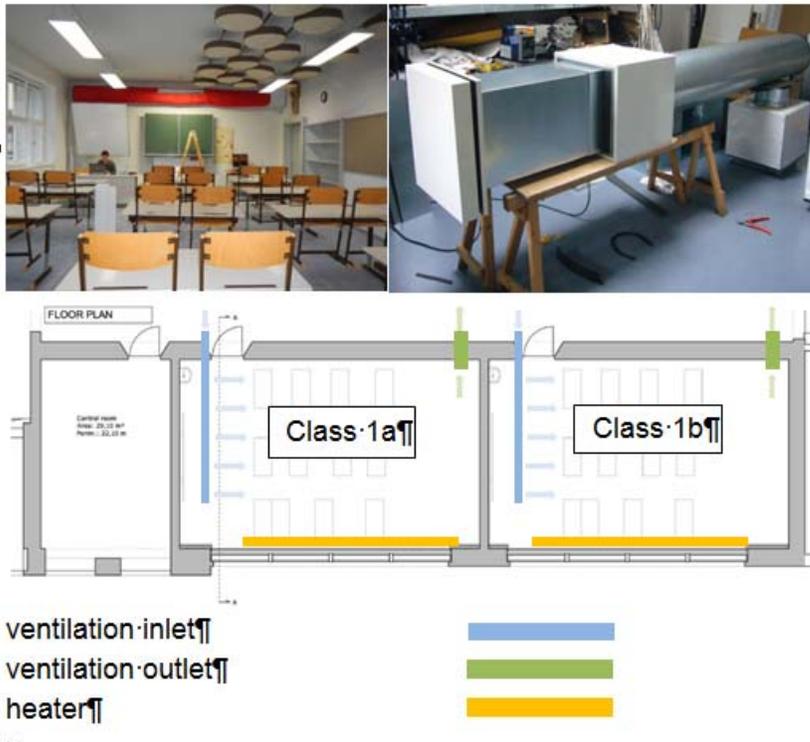
Test-classroom (upper left); Active overflow prototypes with active overflow and silencer manufactured by ATREA (upper right); Ventilation schema (bottom);

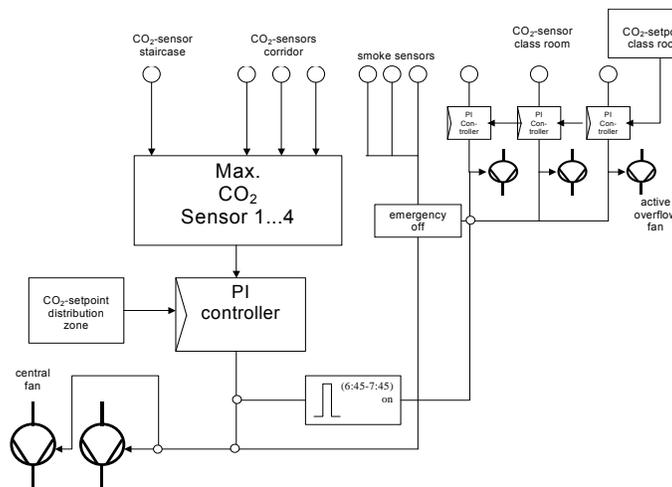
Control scheme for central fans and active overflow fans in case of CO₂-measurement in each class room

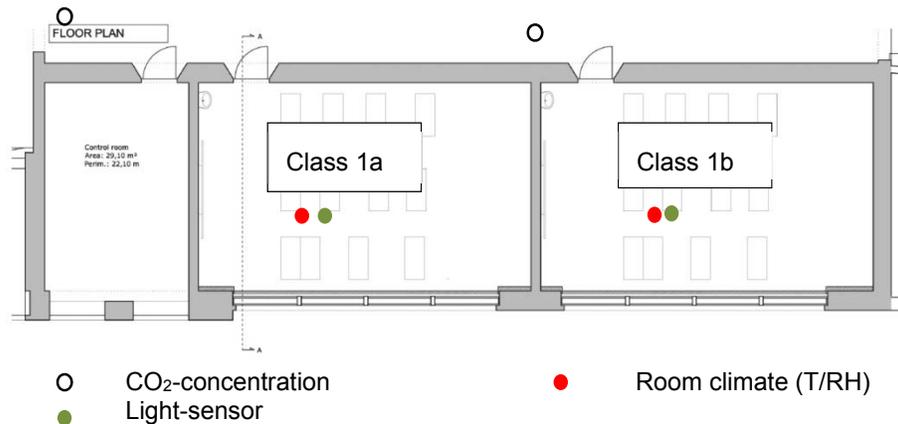
Optimized monitoring system

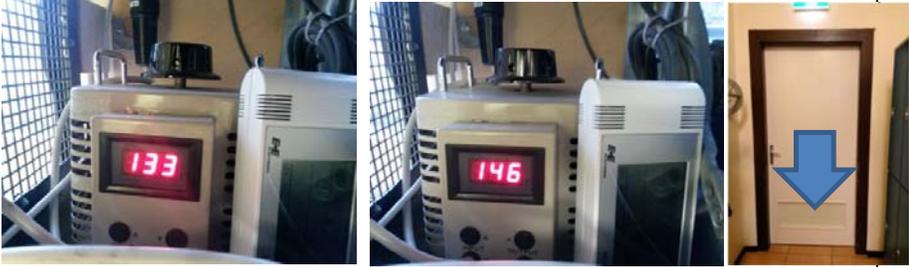
| <p>20.11.2013</p> | <p>08:30</p> | <p>Increase the flowrate of exhaust fan (0B60) from 133 to 146</p> <p>Now the force to open the door is already on a level that small children could have problems to open the doors due to the suction of the fan. The area of the grill on the door should be enlarged. Rainer will be asked how to proceed?</p> |

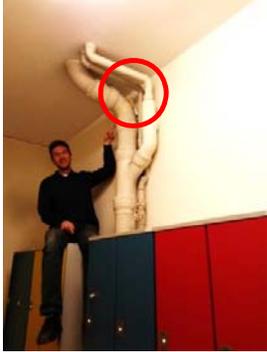
| <p>05.12.2013</p> | <p>17:30</p> | <p>The sensor 0B60 was moved from the exhaust fan casing to the place close to the ceiling within the same room, because there were some suspicion that the ventilator sucks inside some additional air through the untight windows frame. That would explain the low CO2 concentration measured in exhaust fan casing.</p> |

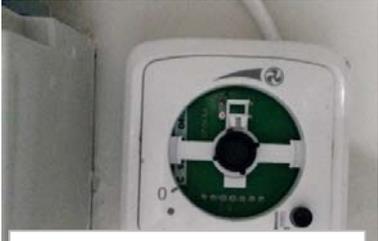
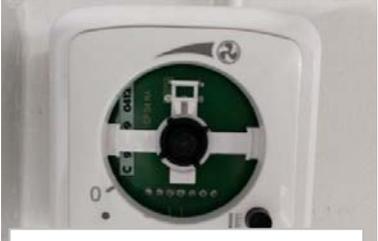
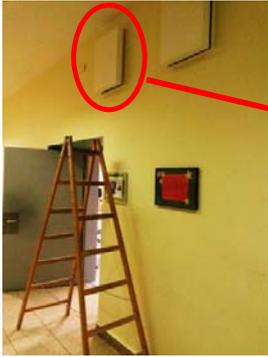
| <p>05.12.201 3</p> | <p>17:30</p> | <p>The flow rate of the supply fans in both classes was increase the to level 550 m3/h.</p> <div style="display: flex; justify-content: space-around;"> <div style="text-align: center;"> <p>Class room 1. Voltage 8.74V</p> </div> <div style="text-align: center;"> <p>Class room 2, Voltage 9V</p> </div> </div> <p>Side and part of the upper corner of the intake cover plate in the corridor, were sealed with tape to prevent suction of the waste from class r. 2 to air supply of class room 1</p> <div style="display: flex; justify-content: space-around;"> </div> |

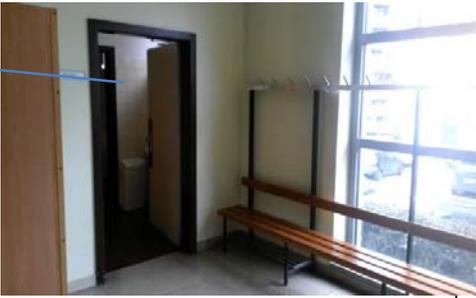
| <p>17.01.201 4</p> | | <div style="display: flex; justify-content: space-around;"> </div> <p>Window in the man´s toilet was opened and the door as well.</p> |
