D7.6 Report on conservation compatibility of the developed solutions and methods

**[Compatible solutions for improving the energy efficiency
of historic buildings in urban areas]**

Project Acronym	3ENCULT
Project Title	Efficient ENergy for EU Cultural Heritage
Project Coordinator	Alexandra Troi EURAC research, Viale Druso 1, 39100 Bolzano/Italy Alexandra.troi@eurac.edu
Project Duration	1 October 2010 – 31. March 2014 (42 Months)

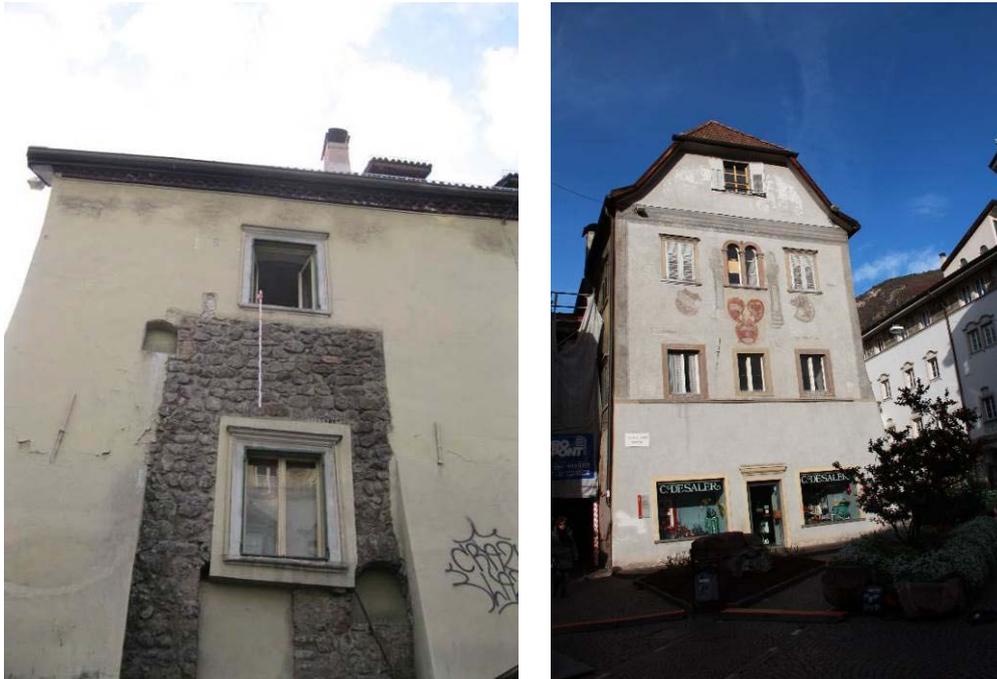
Figure 2.1: East and south façade of the building

Actual state of the building concerning outer surfaces:

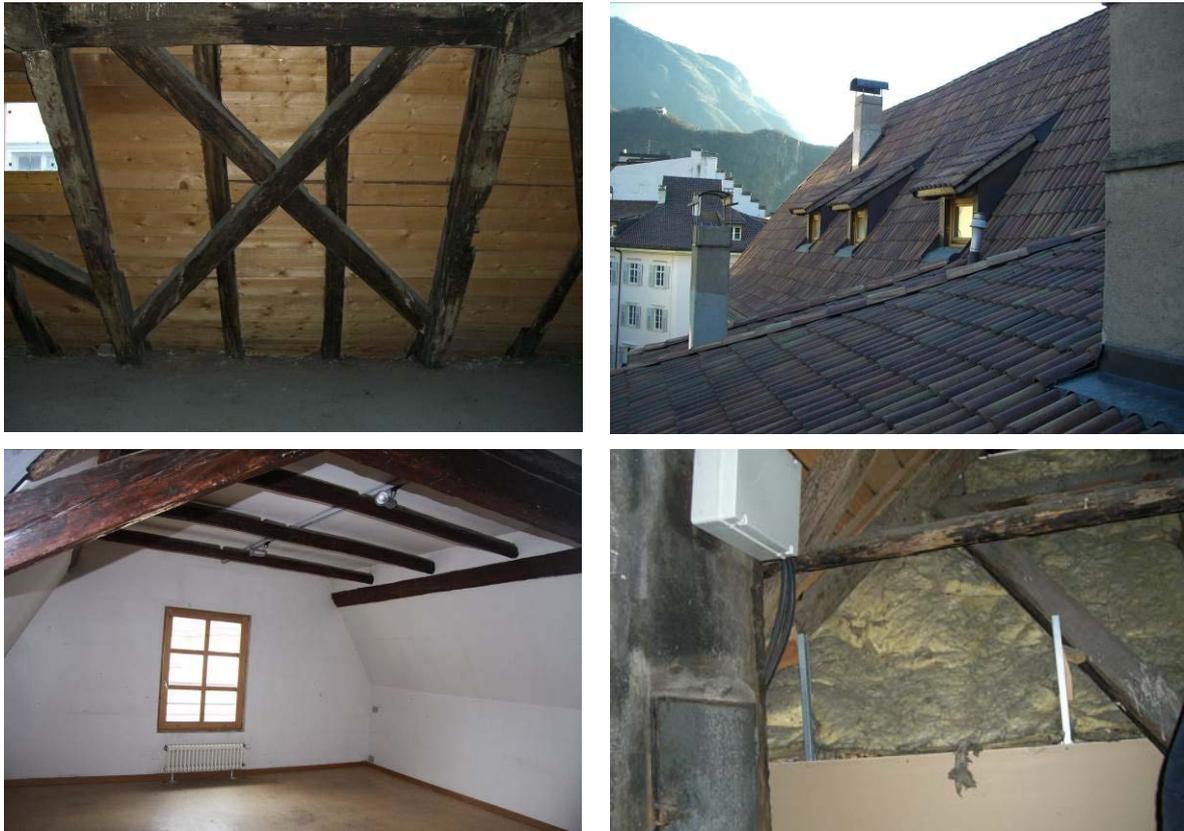
Figure 2.2: Roof of the building from outside and inside, isolated and non-isolated part

Actual state of the building concerning outer surfaces:

- Insulation of the roof: an insulation from inside is thinkable (insulation in between and below the rafters).

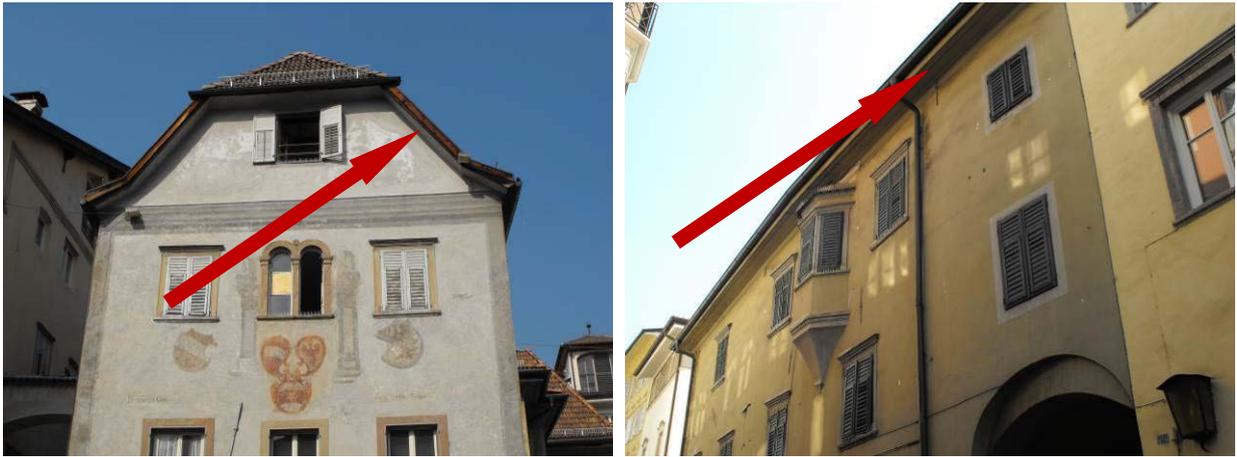
Figure 2.3: Down spout of the roof

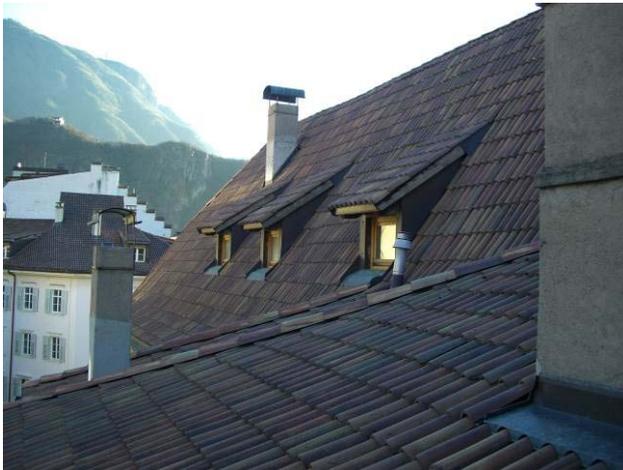
Figure 2.4: Roof dormers of the Weigh House

In case of dormers of a roof, the heritage office usually recommends two type of shapes for the historic city centre: either single dormers with external dimensions of 1,2 x 1,2 m or a long row of windows parallel and near to the roof ridge with a width of 0,7 m.

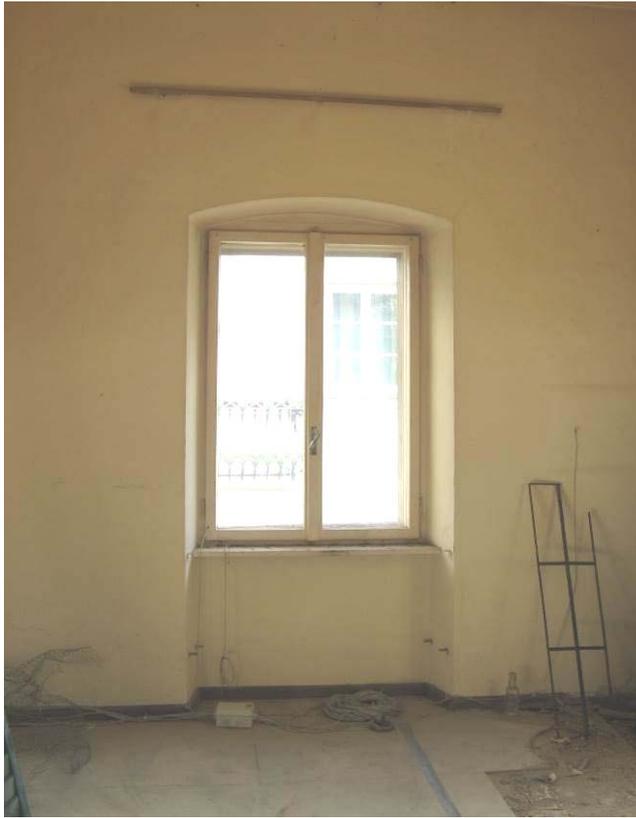
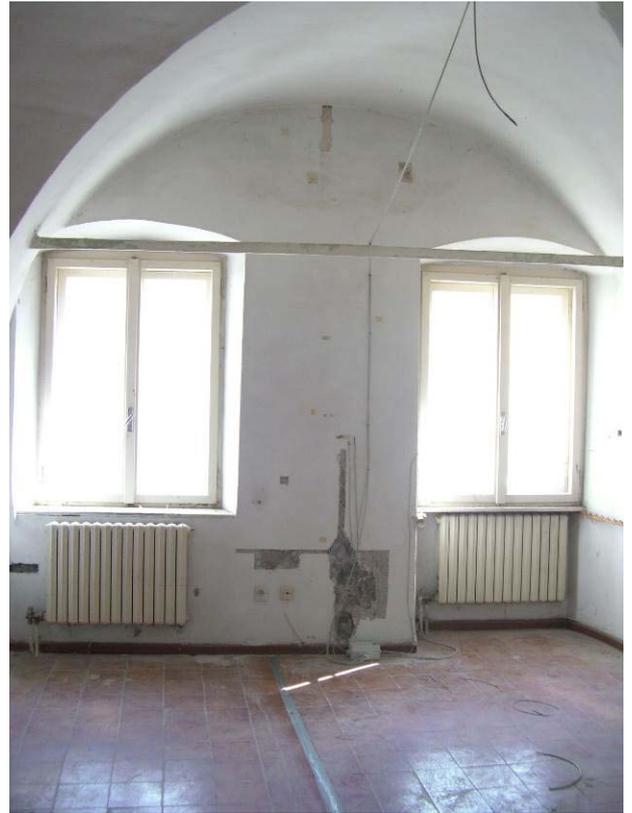
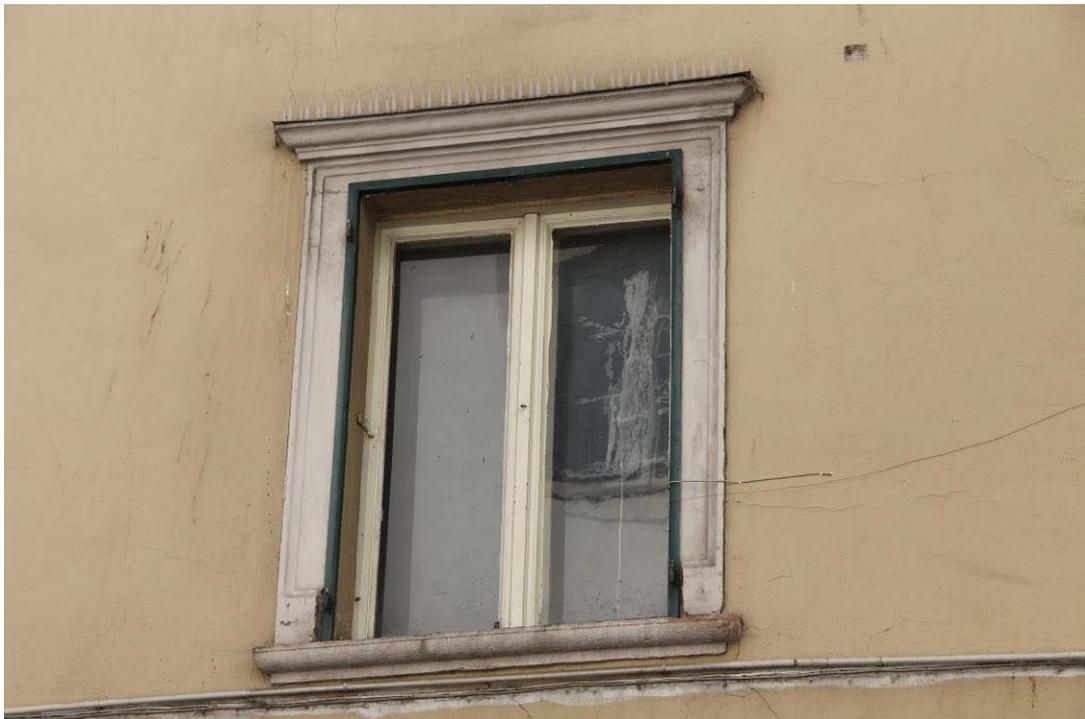
Figure 2.5: Existing window from the 50th/60th of the last century from inside and outside

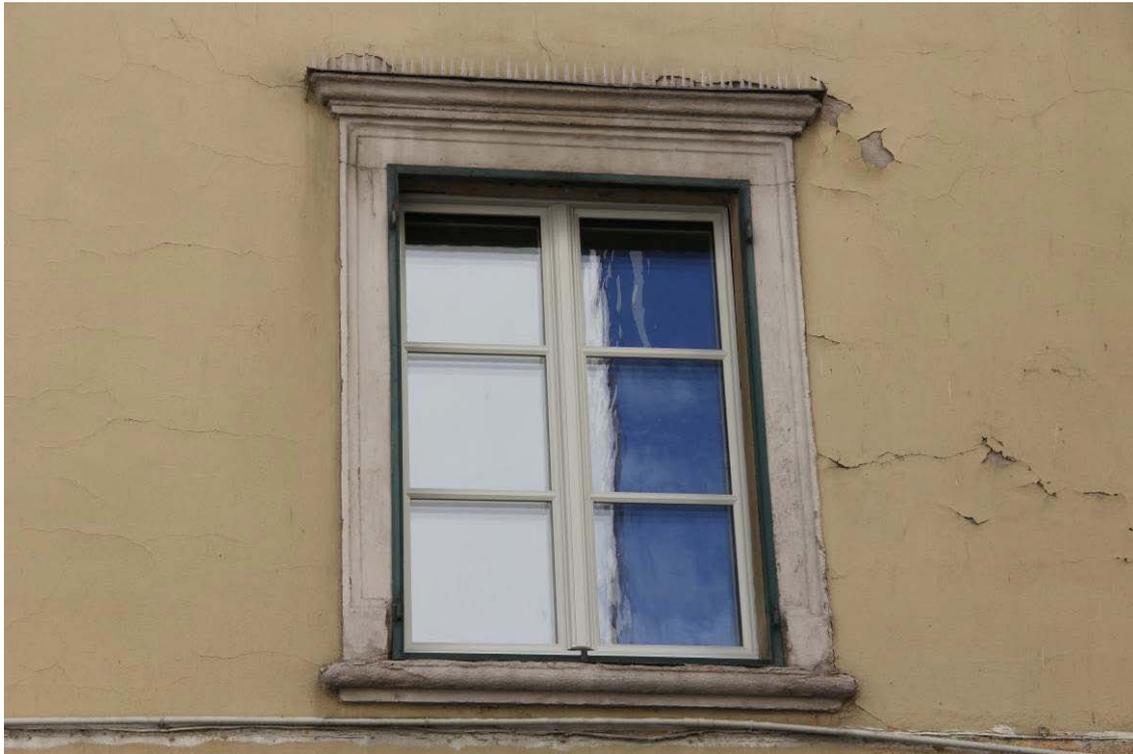
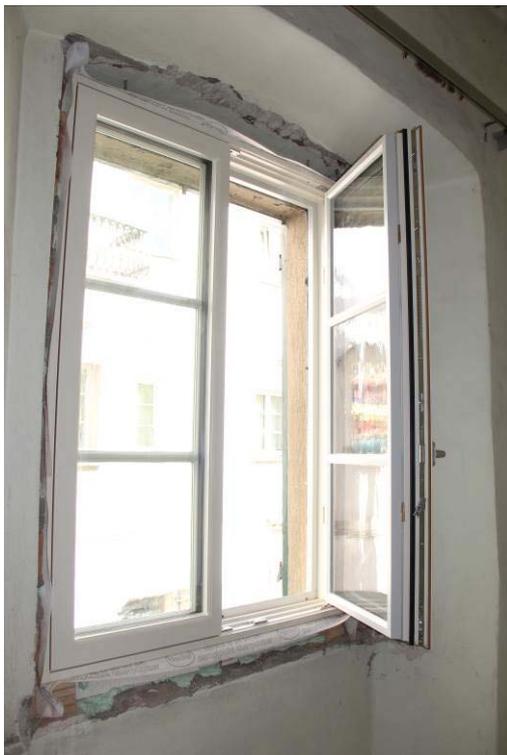
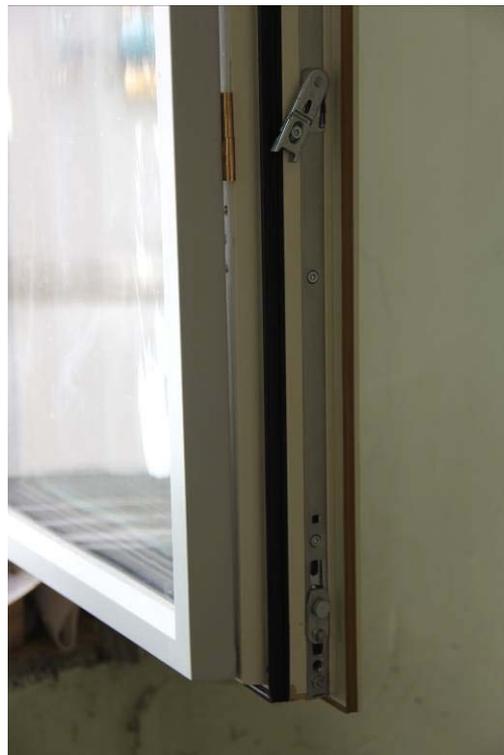
Figure 2.6: First high energy efficient window prototype installed in the Weigh House
Comment by Dr. Kofler Engl (Director of the Heritage Office of South Tyrol) regarding the first window prototype, developed in the framework of the research project 3Encult:

- The optic of the single glazing seems to be "over the top". It does not correspond to the appearance of a historic glass. From the outside, to highly irregular reflection, from the inside to strong irregularities.
- The Heritage Office has not yet found a satisfactory type of glazing that would come closest to the historic glass. It can therefore not make any recommendation for the outer glazing.
- A single glazing in conventional float glass is preferable to the glass used now.

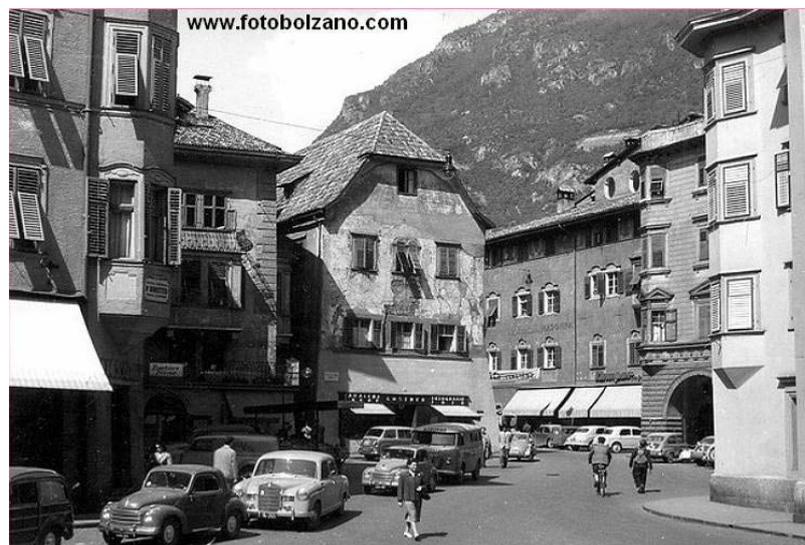
Figure 2.7: Photo from the Weigh House from 1958: On first floor, you can see the original baroque window with the horizontal impost

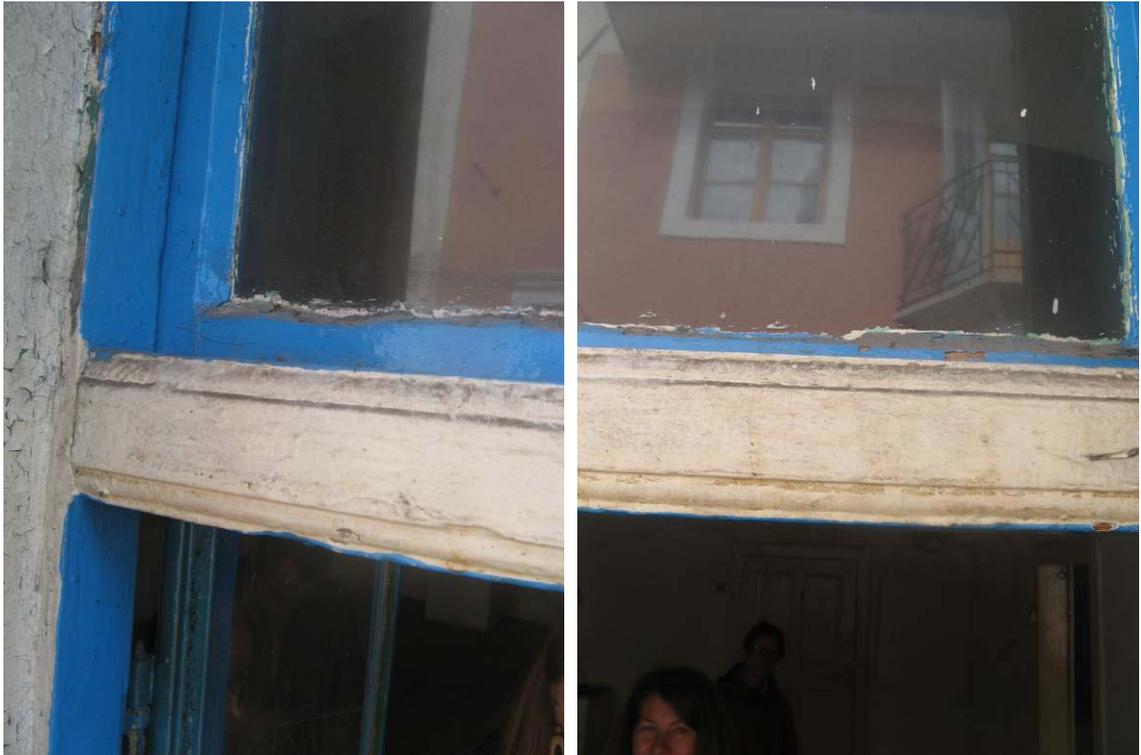
Figure 2.9: Shape of the impost at the bay window on second floor

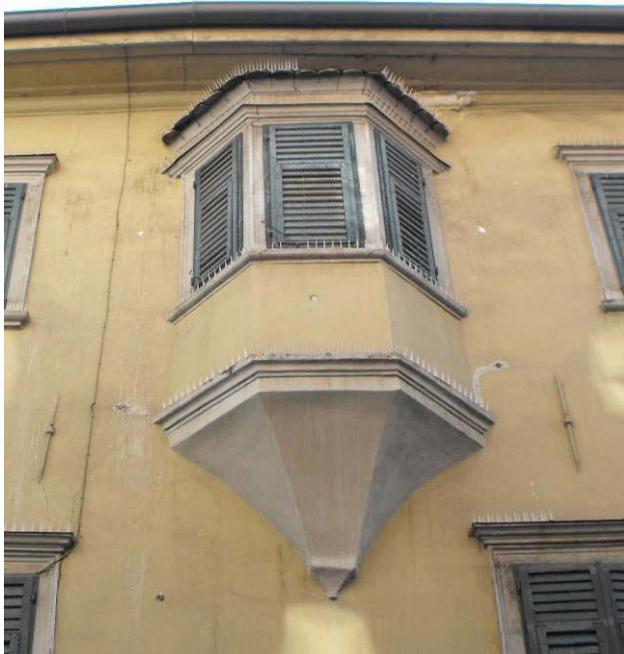
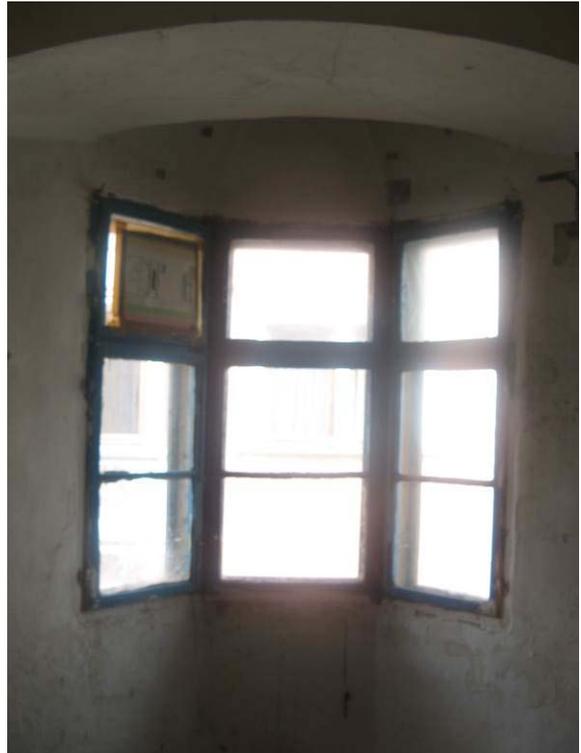
- The three windows of the bay should be preserved, they should be restored and repaired and improved from energetic point of view by an additional window layer.

Figure 2.10: Bay window on second floor (from outside and from inside)

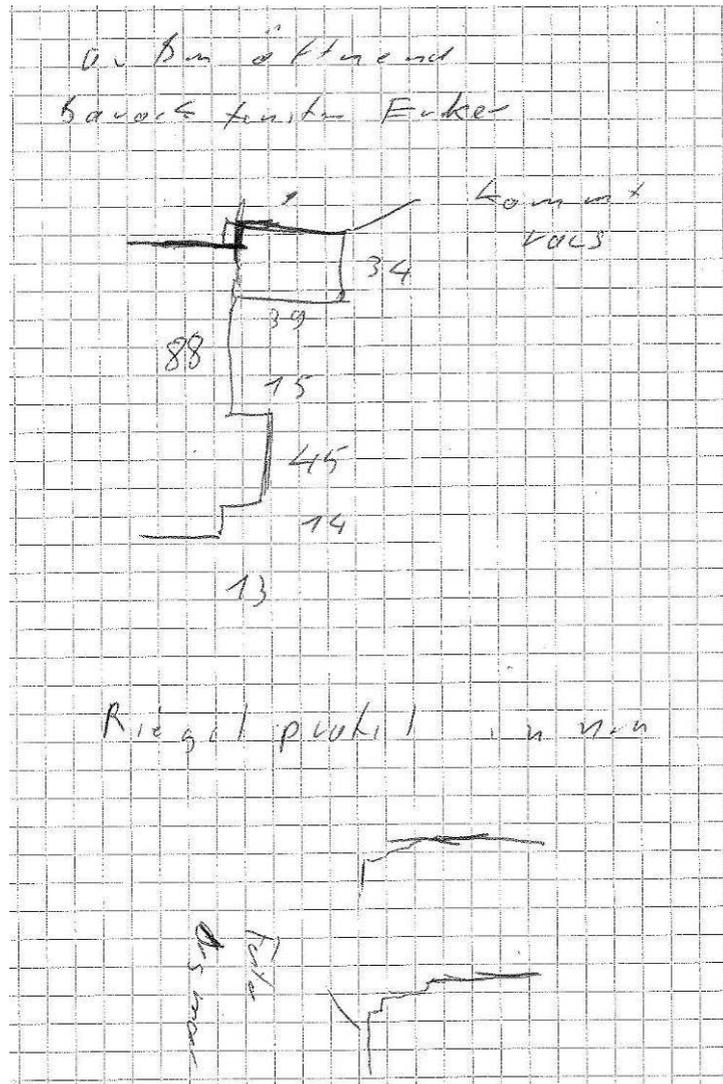
Figure 2.11: Dimensions of the bay window: window frame, exterior reveals and wooden frame on the outer side for fixing the window shutters

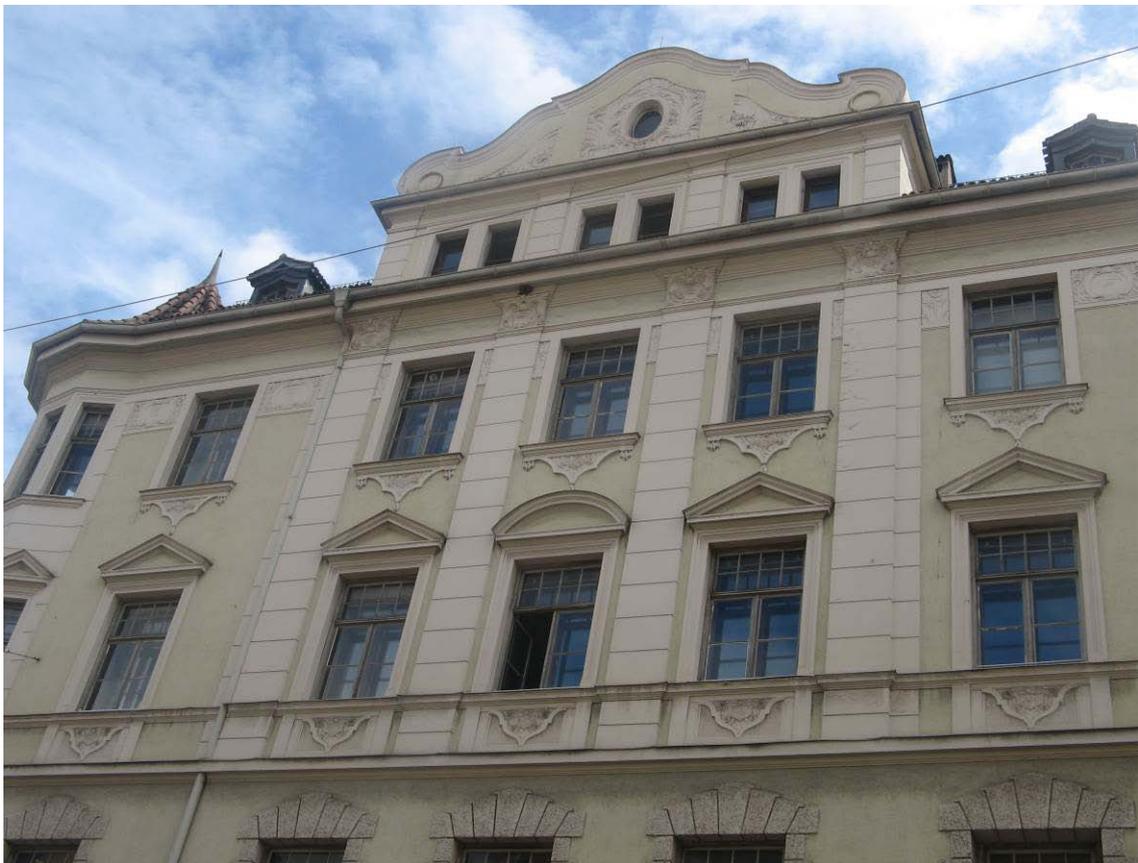
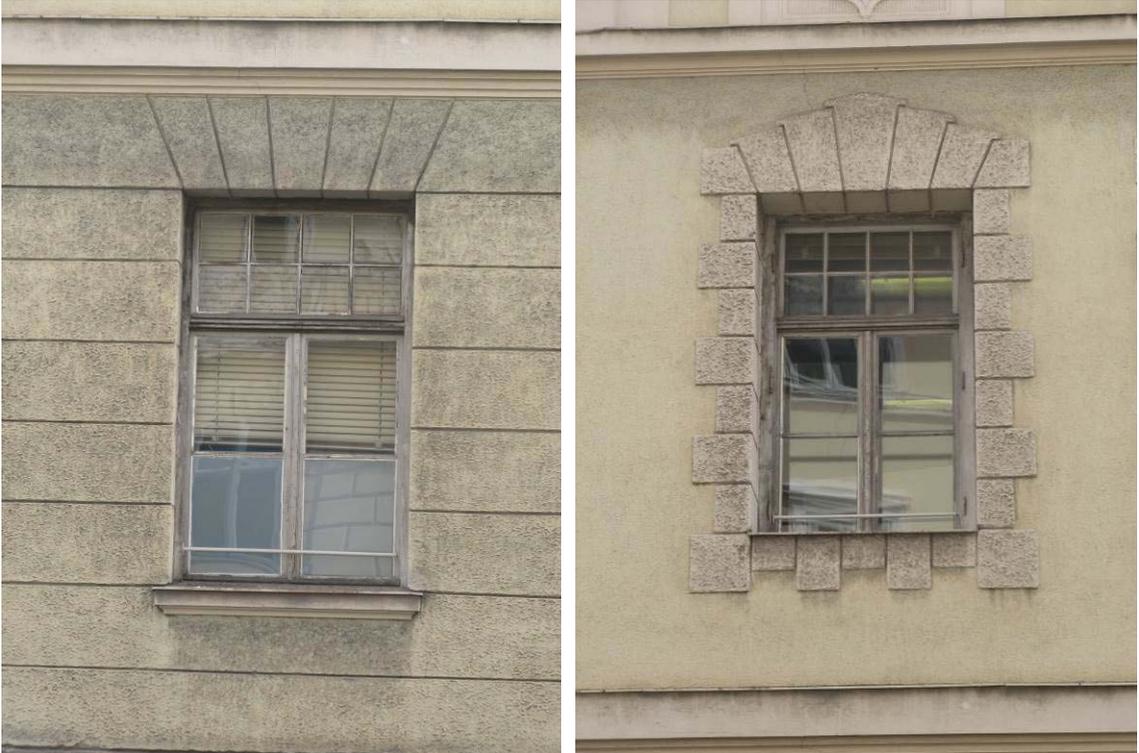
- For the development of an energy-efficient box-type window a box-type window from the turn of the century typical for Bolzano is used as a model
- Appearance, proportions, dimensions and division of the prototype should correspond to those of the model. As template window, the windows from the “Aufschnaiter Middle School” (Leonardo da Vinci Road 13) are selected. The window sashes be able to open inwards.
- The external dimensions (length * width) and the position of the horizontal impost are measured on-site by the case study responsible, the remaining dimensions/proportions assumes the window developer from the photo.
- The prototype is expected to be produced (in coordination with the company Andre) by the company Kranz. It will not be installed, but can be presented “free-standing” at seminars and fairs.

Figure 2.12: Box-type window of the “Aufschnaiter Middle School” in Bolzano

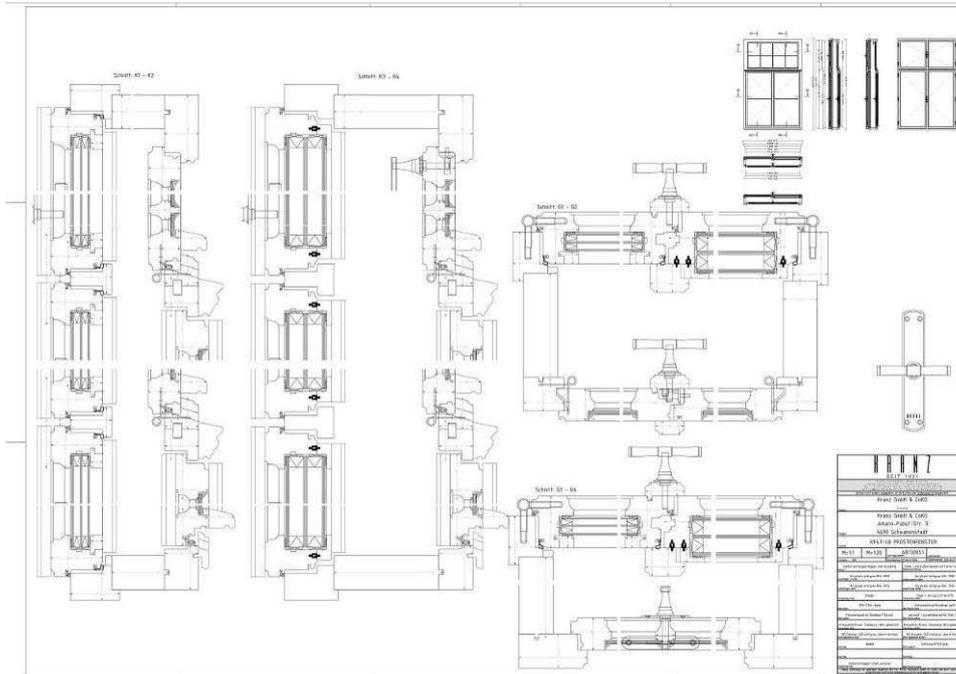
- Single glazing outside: “Restauro leicht”
- Triple glazing inside: still questionable from aesthetical and functional point of view
- Type of wood: local timber: pine or larch. Since the wood is varnished spruce is more recommendable.

- Profiling inside and outside: like in the drawing
- Design of the upper window: rebating inside and on the above side tiling to inside

Figure 2.13: Drawings of the second window prototype for the Public Weigh House (above) and the prototype for a typical box-type window of Bolzano (below)

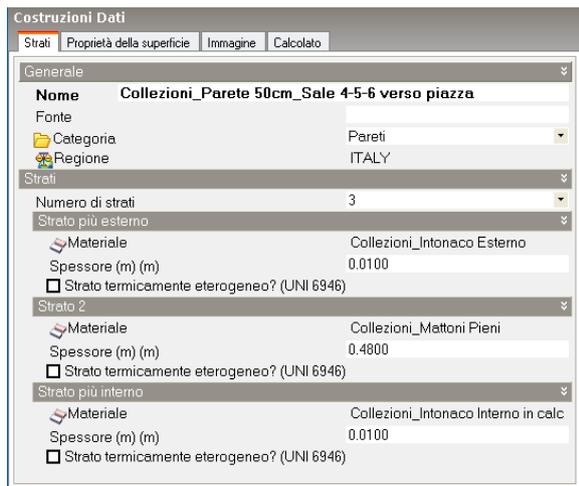
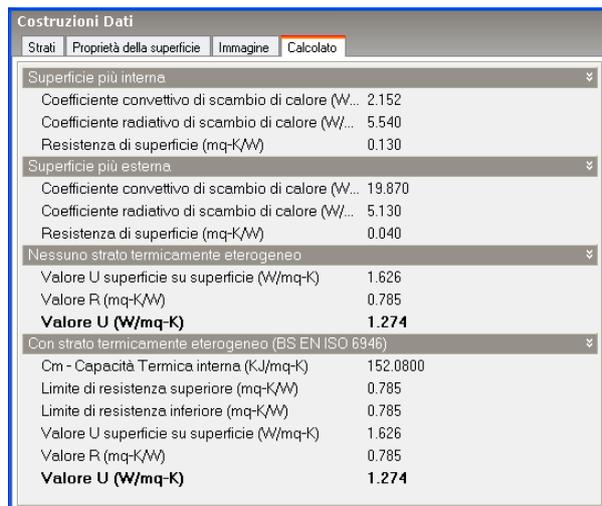
The following step was defining in detail the thermal and physical characters of the several building components (walls, ceilings, pavements, shutters) using the information given by the present study; in particular for the solid components, the necessary materials have been virtually rebuilt, defining the relative physical properties such as conductivity [w/mK], specific heat [J/kgK] and density [kg/m3].

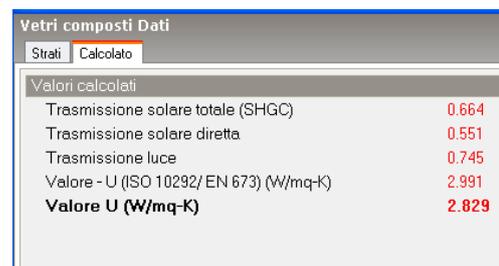
In Tab “Construction” has been defined the infiltration index (ACH-Air Change per Hour) which considers eventual cracks in walls and in windows.

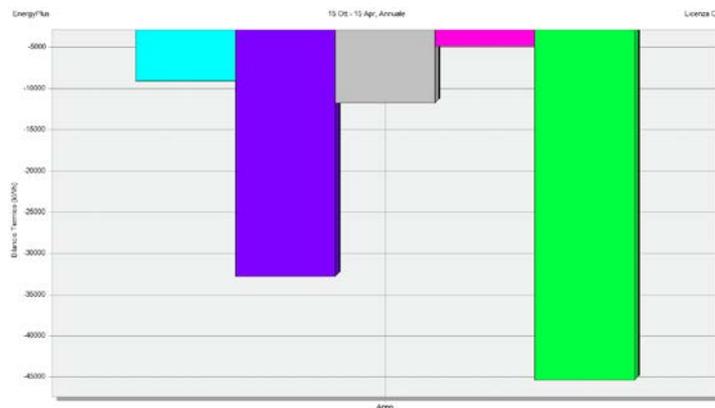
Losses through the building external enclosure body (whole period)

The highest level of loss is due to external infiltrations caused by:

- the low thermal performances of the window shutters made in wood frames without seals;
- the thin interface between window and mobile frame and between fixed frames and the walls;
- the presence of installations going through the perimeter walls;
- the presence of cracks among the beams of the superior wood coffered ceiling

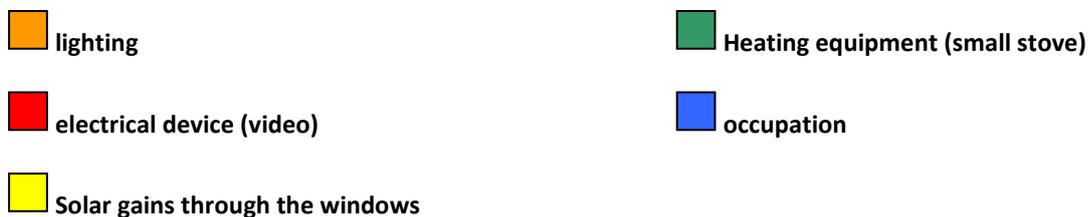
Contribution through the building external enclosure body (whole period)
