Case Study

WASTEWATER HEAT RECOVERY (WWHR)

GYMBOX FARRINGDON

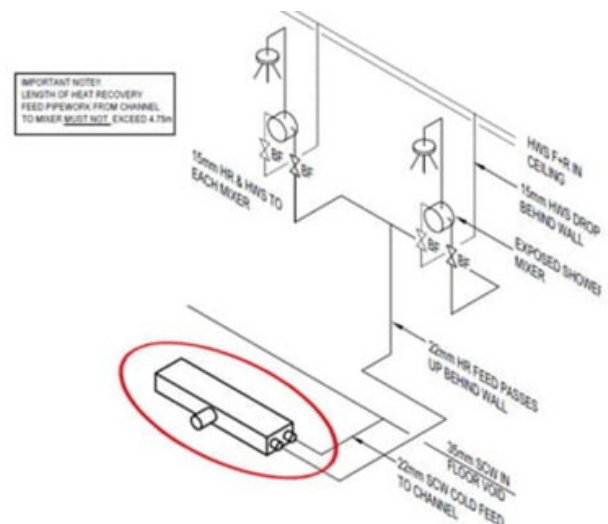
- Hot water-using bathing appliances connected**

A WWHRS device is shared for every two showers. The heat of every shower is recovered.
