COVID-19 guidance & case studies for specific space types

Atze Boerstra

REHVA board member, president CLIMA 2022,
managing director bba binnenmilieu

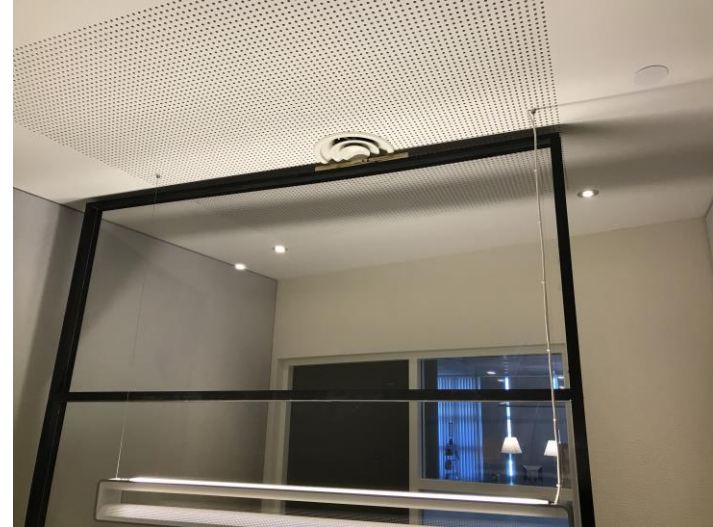
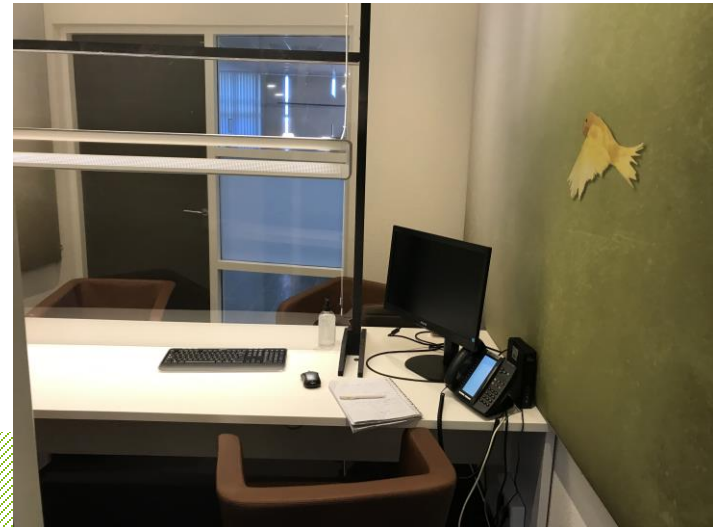
Consultation room CASE

- Internal room in city hall
- No (operable) windows
- Used for one-on-one meetings civil servants with citizens
- Mechanically ventilated space
- Meetings can last up to 1,5 hours
- Volume room: +/- 25 m³

- Measured fresh air supply: **7 m³ / hr per persoon**
- Reference value NL building code: 14,4 m³/hr per persoon
- Challenge: lots of **talking** (= elevated virus emission risk)
- Advice: use OTHER rooms

1	2	17	18	19	20	21	22	23	24	25
Ruimte nr.	Type ruimte	Ventilatie	Q per m ²	Q pp	Q pp	BB eis	Voldoet?	BB eis	Voldoet?	BB
		voud		COVID	normaal	nieuwbw		best. bw.		eindscore
		[-]	[m ³ /h/m ²]	[m ³ /h pp]	[m ³ /h pp]	[m ³ /h pp]		[m ³ /h pp]		
<i>Begane grond</i>										
0.01	Overlegkamer	0,8	2,2	7	5	14,4	Nee	7,6	Nee	Rood X
0.02	Overlegkamer	0,8	2,2	7	5	14,4	Nee	7,6	Nee	Rood X

Ruimte nr.	Type ruimte	Oppervlakte	Te openen	Wells Riley	Besmettingskans
		[m ²]	raam?	besmettingskans bij I=1	score
<i>Begane grond</i>					
0.01	Overlegkamer	9	Nee	61%	Rood
0.02	Overlegkamer	9	Nee	61%	Rood

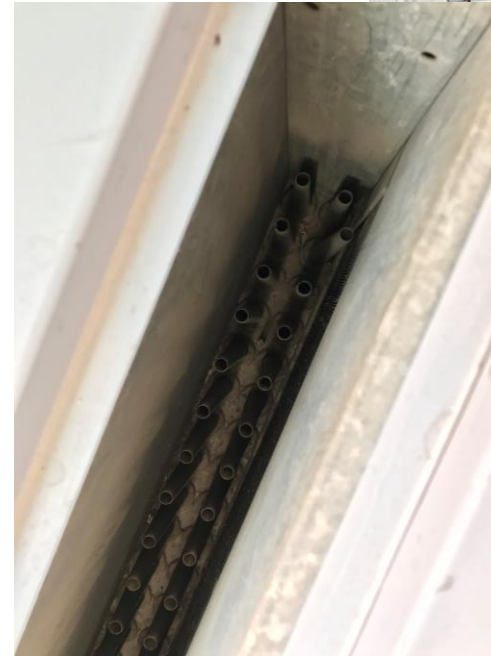
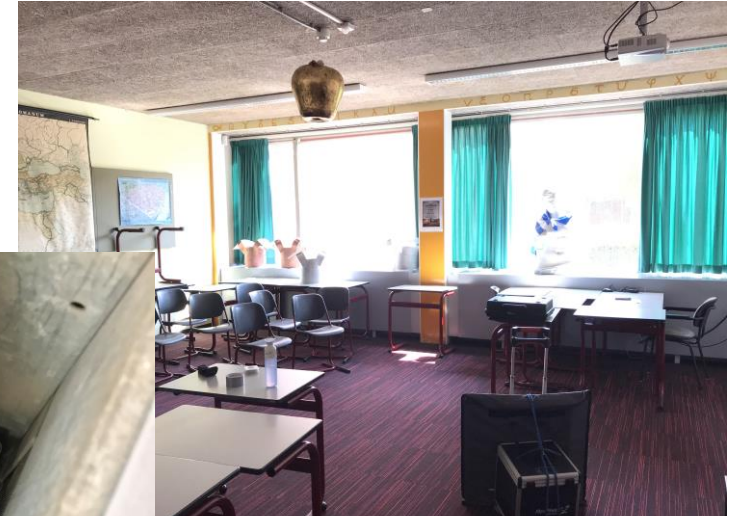
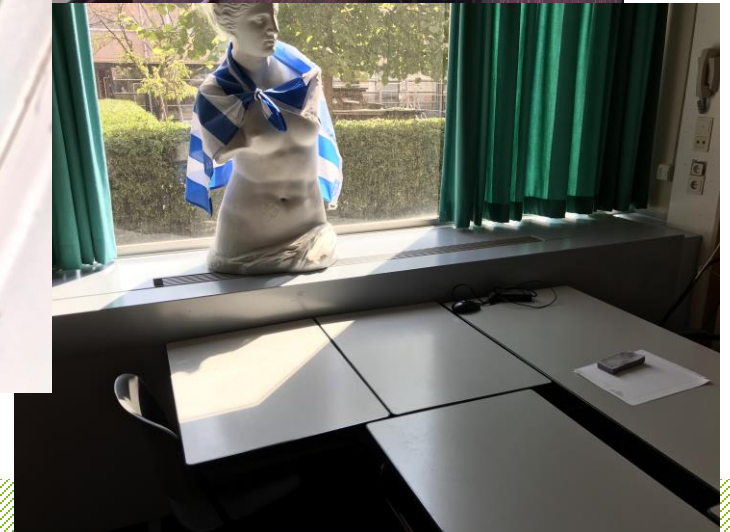
Classroom CASE

- Secondary school
- No operable windows
- Outdated mechanical ventilation system
- Length of lessons: 80-160 minutes

- Measured fresh air supply: **7-11 m³/hr per persoon**
- Substantially less than building code / 'Frisse Scholen PvE' requirements
- Good news: from january > new building designed at 'class A level'
- Advice: till X-mas rent portable air cleaners (HEPA / electrostatic filter type)

Ruimtenr.	Functie	Aantal personen	Gemeten Ventilatie-debiet [m ³ /uur]	Ventilatie per persoon [m ³ /uur]	Voorschriften bouwbesluit bestaande bouw pp. [m ³ /uur]	Voldoet?	PvE Frisse Scholen Klasse C [m ³ /uur/pp]	Voldoet?
001	Klaslokaal	31	275	9	12,4	Nee x	21,6	Nee x
002	Klaslokaal	31	331	11	12,4	Nee x	21,6	Nee x
109	Klaslokaal	31	205	7	12,4	Nee x	21,6	Nee x

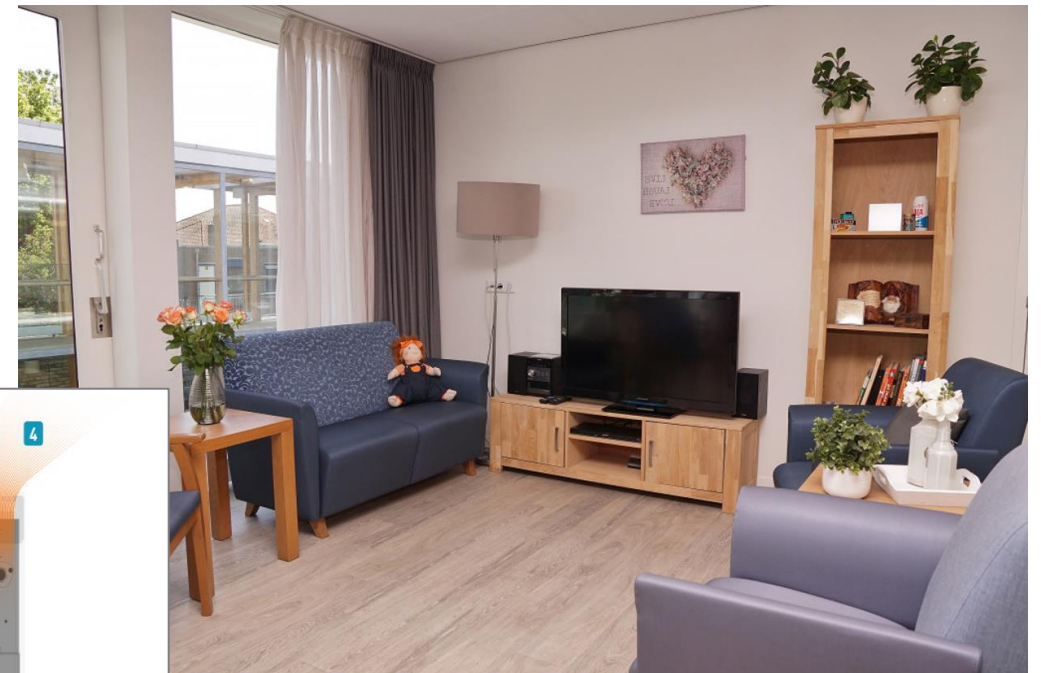
Demand (CO₂) controlled decentralised ventilation

- Living room in nursing home
- **Demand-controlled** system, integrated in facade (normally in 'eco-mode')
- Setpoint > 1000 ppm
- Combination of fan coil unit (right) with fresh air supply unit (left)
- *Facility manager: 'cross infection risk due to recirculation & high velocity air currents'*

- 'Air current hypothesis' rejected
- Main problems seemed to be: ventilation system 'off' most of the time
- Actual fresh air supply per person much lower than building code value (22,3 m³/hr pp)
- Advice 1: reprogram the ventilation units / fresh air supply settings (and start using the heating/cooling function again)
- Advice 2: monitor IAQ with 'CO₂ traffic lights' in all living rooms, meeting rooms etc
