Thermography – predictive maintenance technology for HVAC system reliability and safety improvements

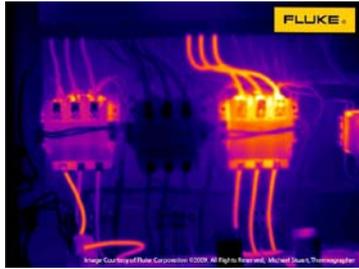
Figure 1. L1 cable on the connector to the left shows overheating due to a bad connection. This may be the result of a loose corroded connection.

Recommended action: repair and check afterwards if the overheating on the connection and cable has disappeared.

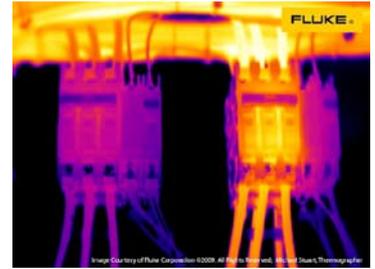
Figure 2. The connector to the right shows a higher temperature in all phases because of a higher electrical load.

Recommended action: verify with a clamp that there is no overload. If the load is under the nominal load, but the temperature is above the recommended (normally 70°C for PVC cables), check with a power quality (PQ) meter the presence of harmonics.

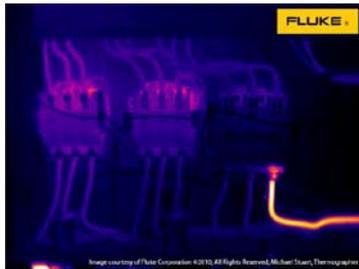
Figure 3. The image shows clearly that the L3 phase on the third connector from the left is overheated due to a bad connection.

Recommended action: guidelines provided by the InterNational Electrical Testing Association (NETA) say that when the difference in temperature (DT) between similar components under similar loading exceeds 15°C immediate repairs should be undertaken.

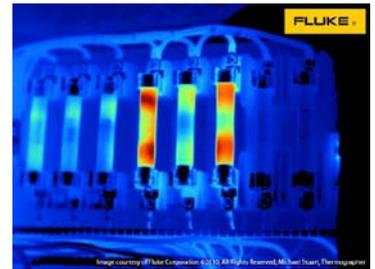
Figure 4. Fuses in L1 and L3 show overheating and non-uniform temperature.

Recommended action: check the loads for unbalance and if necessary replace fuses.

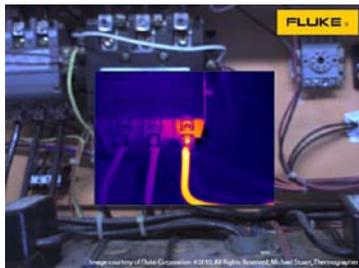
Figure 5. High resistance electrical connection on L3.

Recommended action: check load and difference in temperature (DT) to the other phases to determine severity (slight, moderate, severe or extreme).

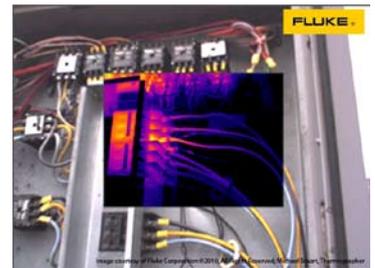
Figure 6. Electrical system inspection to check for loose connections. Load measurement shows 75% and temperature of only 45°C.

Recommended action: repair at the next scheduled maintenance.

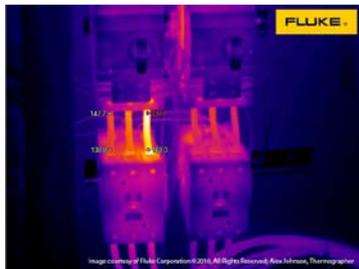
Figure 7. The temperature difference between L3 and L1 is 22.7°C which according to the InterNational Electrical Testing Association (NETA) means an indication of a serious issue. In addition to that, the temperature on the L3 cable is 84.3°C. According to European Committee for Electrotechnical Standardization – CENELEC HD 516 – insulated cable temperatures (PVC) should not exceed 70°C to avoid short circuits, interruptions and fires.

Recommended action: replace L3 cable and check insulation on the other cables.

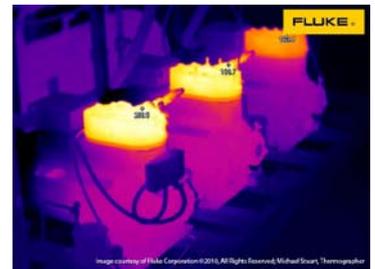
Figure 8. Possible issue when operating first compressor. The temperatures of the middle and right compressors are 55–67 °C lower than the first compressor on the left.

Recommended action: check working loads and compressor operation to determine the reason for the significant temperature difference.

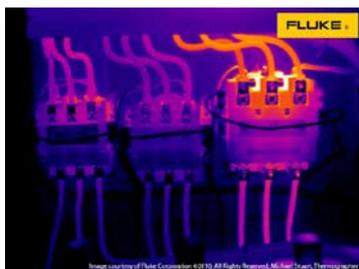
Figure 9. Loose or high resistance electrical connections on all 3 phases. Measured current is 80% of nominal which is the normal load in this case. Temperature on the upper cables is about 20°C above the ambient temperature of 23°C. This is still less than 35°C above ambient as per IEC 947-1 table 1.

Recommended action: there is no reason to assume the insulation on the cables has been damaged. Repair and conduct another checkup within 3 months.

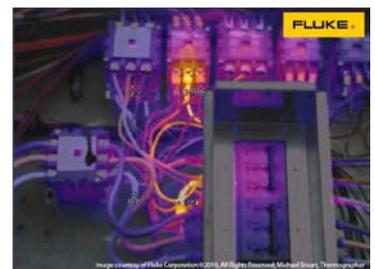
Figure 10. Bad connections caused the temperature of the cables to be above 70°C. This is above the limit recommended by European Committee for Electrotechnical Standardization – CENELEC HD 516 for PVC cables.

Loads at present are low, about 50% of nominal. It is unknown what temperature the cables were exposed to when the loads were at near 100%. According to IEC60724, the short circuit current for a PVC cable with a cross section <300mm² is maximally 160°C for 5 minutes.

Recommended action: measure cable insulation and replace cables if necessary.
